AIAS 2018 International Conference on Stress Analysis

## Fatigue life evaluation of car front halfshaft

*Keywords:* car halfshaft; fatigue assessment; reverse engineering.

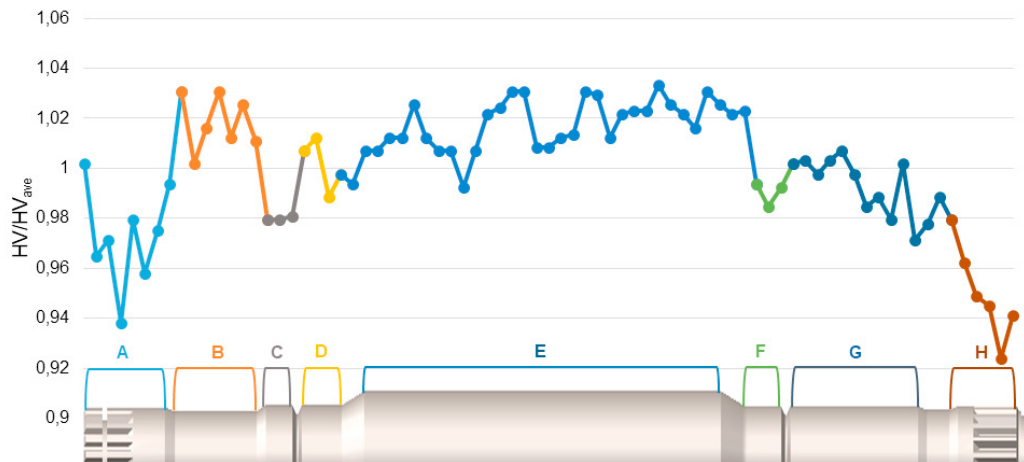
Fig. 3. Hardness trend on the halfshaft for the different sections.

In micro-hardness tests, the area described by the indenter can be related to the hardness of the material. In Fig. 3 are reported the values of the ratio between the local hardness of the material and its average along the length of the halfshaft. As can be seen from the hardness trends on the halfshaft, higher hardness values are found in areas where the component has a constant and fairly regular cross section (B, E and G sections) while, where there are more detailed machining, such as the spline profile (A and H sections), we have relatively lower hardness values. The hardness investigation shows how mechanical machining lead to critical sections in the halfshaft extremities, especially in the spline profile.

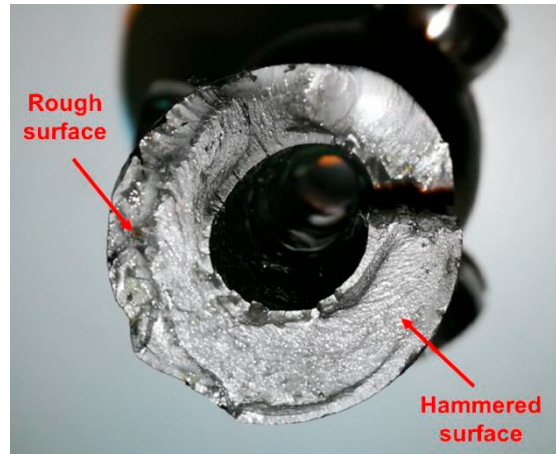
Fig. 4. Failure surfaces of the halfshaft

From a macroscopic analysis of the failure surfaces we can obtain important information about the way of failure. The failure surfaces on the halfshafts show two different areas, typical of a fatigue breakage (Fig. 4): a smooth area,

produced by hammering prior to the break, and a rough area, due to a sudden brittle failure. Detailed observation at microscope of the crack shows that it starts from the root of the spline profile (Fig. 5a), propagate transversally along the teeth then it deviates from an angle of  $45^\circ$  (Fig. 5b) and propagate longitudinally up to the failure zone (Fig. 5c).

One of the reason because the crack starts at the spline profile is due to the complex geometry and the local mechanical machining which lead to a high stress concentration factor. Another reason could be the forcing of the tripod on the spline profile, which causes residual stresses in that critical zone of the halfshaft.
