DOI: 10.1002/suco.202200367

# Assessment and strengthening of reinforced concrete bridges with half-joint deterioration

Michele Fabio Granata<sup>1</sup> | Lidia La Mendola<sup>1</sup> | Davide Messina<sup>2</sup> | Antonino Recupero<sup>2</sup>

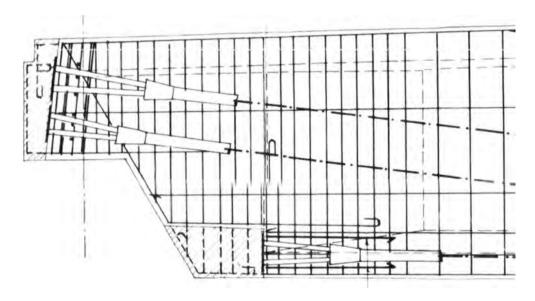
For each case, the presence of prestressing is generally beneficial, also because the internal tendons have the anchor head right in line with the saddles, entering those areas with a favorable inclination for shear behavior, through the vertical component of inclined prestressing that is in the opposite direction to that of the external load (Figure 3). Moreover, the prestressing provides a further benefit through the presence of the axial force.

FIGURE 3 Saddle with prestressing tendons

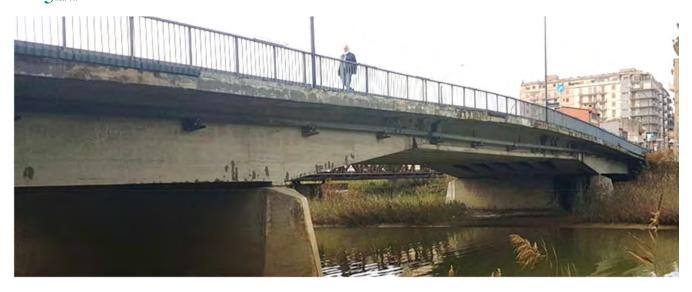
FIGURE 4 View of the bridge

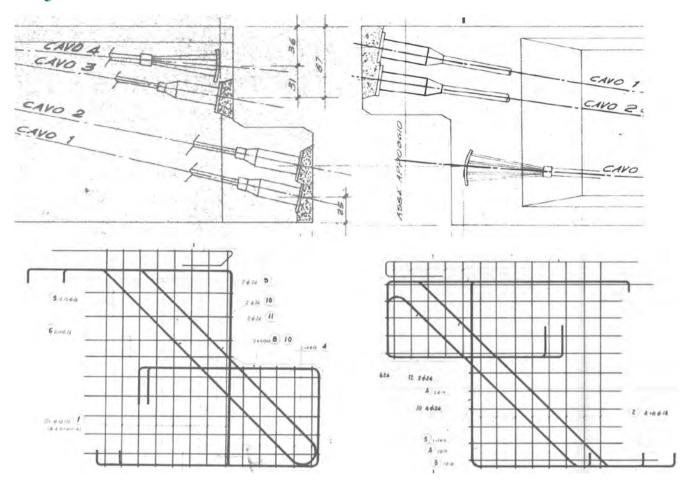
In this case, the Gerber saddle configuration is the classic one with two dapped-end beams that meet on the bearing axis. Both corbels host two prestressing tendons, while the transverse beams are present behind the saddles and affect the entire height of the beam. This configuration of transverse beams implies that the lower corbel of the saddle is only on the beam width, and hence the crossbeam does not contribute to the strength of the saddle. Figure 13 shows the arrangement of tendons and reinforcements for the two dapped-end beams.

Prestressing tendon configuration in the saddles and ordinary reinforcement arrangement

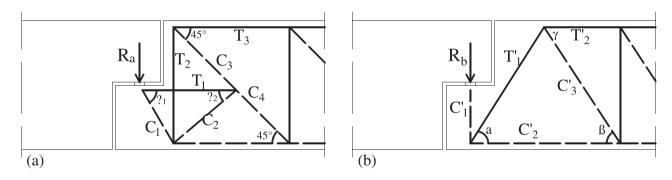
FIGURE 14 EC2 strut-and-tie models of the half-joint. (a) Model with horizontal and vertical ties; (b) model with inclined tie

With a check at ULS, using partial safety coefficients of loads and materials provided by Eurocode, the weakest elements were always found to be the vertical tie T2 and the inclined one  $T_1{}'$ , with capacity  $V_{Rd}=2016\,kN$  and demand  $V_{Ed} = 1549$  kN, leading the safety coefficient to 1.30, considering the contribution of prestressing. The evaluation with all partial safety coefficients set at 1 gives an estimated capacity  $V_{Rd} = 2542 \text{ kN}$  with demand  $V_{Ed} = 1133$  kN, making the actual global safety coefficient equal to 2.24, which is rather high. The contribution of the prestressing tendon considered as reinforcement (steel cross-section area) is neglected in this evaluation. Consequently, the contribution to tension of the tendon in the failure mechanism is not considered, because in the anchoring area it cannot be considered as effective as in the areas where compatibility between concrete section and tendon is achieved thanks to sheath grouting (bonded tendon). In this connection, the present evaluation was carried out locally on the saddle considering prestressing with unbonded tendons.

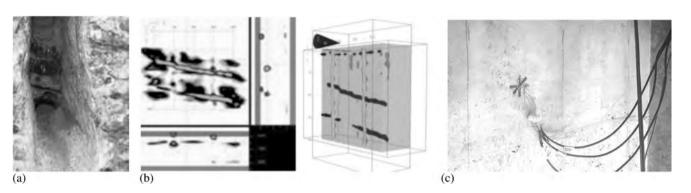
was carried out through corrosion potential mapping, in order to evaluate the status of the reinforcements, that is, whether the rebar was subjected to a generalized or localized corrosion attack or not. This method does not provide any quantitative information on the corrosion rate or the extent of the damage that has already been produced but is particularly suitable for a first definition of the corrosion potential of the structure, coupled with further investigations. The potential method is based on the fact that any condition of corrosion (non-corroded, generalized, or localized corrosion) corresponds to a variation of potential within typical intervals.<sup>25–27</sup> In the case study, some Gerber saddles showed a corrosion potential much lower than -300 mV, with minimum values of -450 mV, indicating a high risk (Figure 15). In other saddles of the same bridge, on the other hand, a moderate potential between -50 and -300 mV was found, with a more limited risk. The overall situation still highlights risks from moderate to high due to the exposed reinforcements of the Gerber saddles.

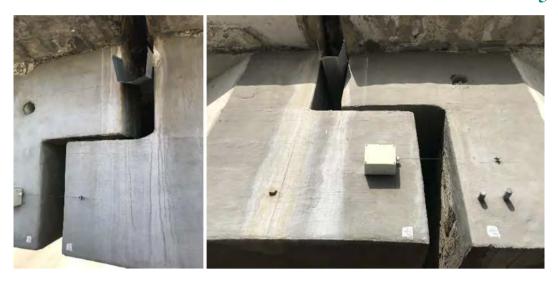
FIGURE 17 Concrete jacketing of Gerber saddle with CFRP fabrics

- 1. Concrete jacketing with or without FRP, which is aimed at improving the concrete properties, restoring the cover, and inserting new reinforcing bars (Figure 17).
- Steel plating for external strengthening<sup>12</sup>; it provides a
  higher degree of reinforcement than the previous
  interventions but is very invasive and requires adequate spaces for rehabilitation works (Figure 18).
- 3. Strengthening by inserting vertical or inclined Dywidag bars, <sup>13</sup> which limits diagonal cracking and increases the overall strength through local prestressing of the saddle (Figure 19).

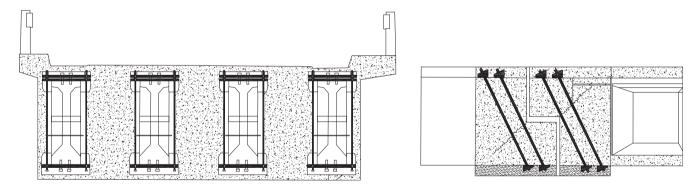
Gerber saddle retrofitting with prestressing bars in Vargas bridge<sup>13</sup>

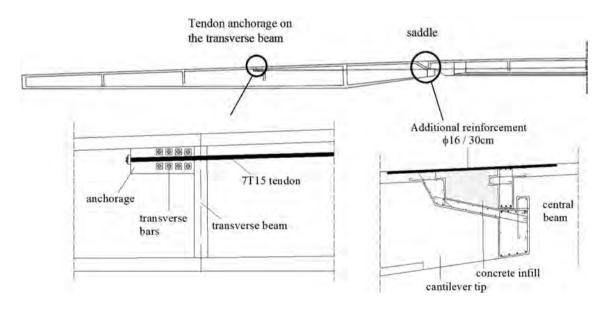
FIGURE 23 Details of retrofitting with external prestressing of the first case-study

bending/shear failure of a different cross-section, far away from the saddle. Without a global intervention with saddle closure and overall strengthening of the deck, this failure mode cannot be avoided.
