Article

A Combined Experimental-Numerical Framework for Assessing the Load-Bearing Capacity of Existing PC Bridge Decks Accounting for Corrosion of Prestressing Strands

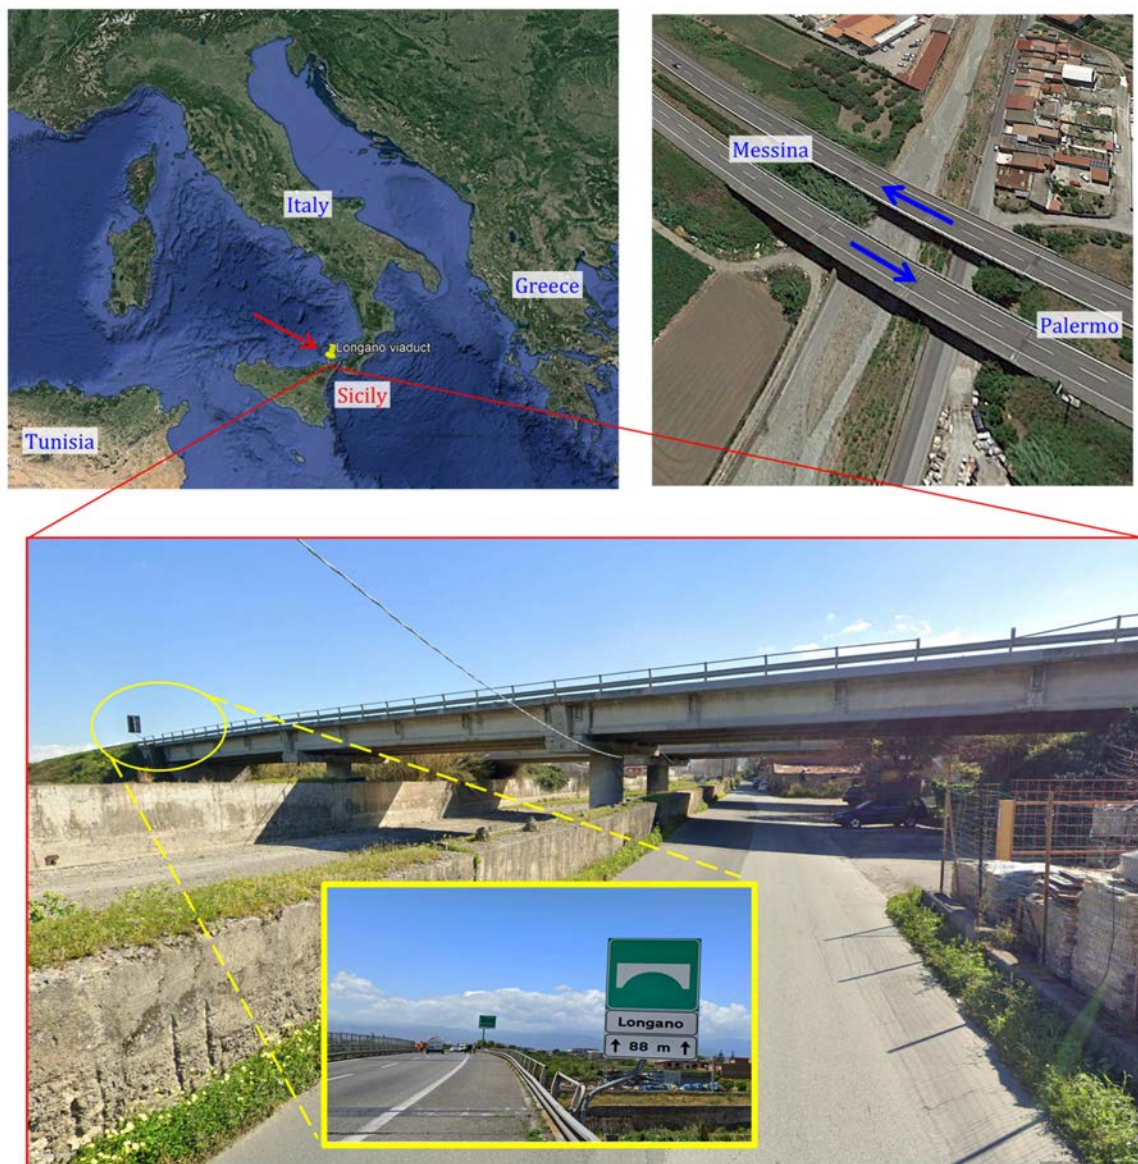
Figure 1. Location and photograph of the Longano viaduct, Barcellona P.G., Italy analyzed in this paper as a case study. (Base map © 2021 Basarsoft US Department of State Geographer Data, U.S. Navy, GEBCO Image Landsat/Copernicus).

With an overall length of 88 m, the viaduct is articulated in two twin parts, each representing an independent roadway, with a straight longitudinal configuration and modest altimetric variations. Each roadway (one following the traffic direction from Messina to Palermo and the other in the opposite direction) is composed of: 2 circular piers of heights 5.50 m and 6.00 m, having diameter 2.20 and equipped with spiral reinforcement and Dywidag prestressing steel bars with diameter 32 mm; 2 abutments with height 6 m and 7 m in RC; 3 spans with a statically determinate scheme in PC, having length equal to 29 m (two external spans) and 30 m (central span); RC slab having thickness 20 cm and width 11 m, including curbs and parapets. The structural scheme is composed of an assembly of 4 longitudinal I-shaped PC girders, spaced 2.75 m, with 42 pretensioned steel 0.6'' strands, of which 26 in the bottom flange, 2 in the web, 4 in the top flange (all of them arranged in straight configuration) and the remaining 10 inclined from the upper portion of the section (near the girder supports) to the bottom flange via intermediate deviators located

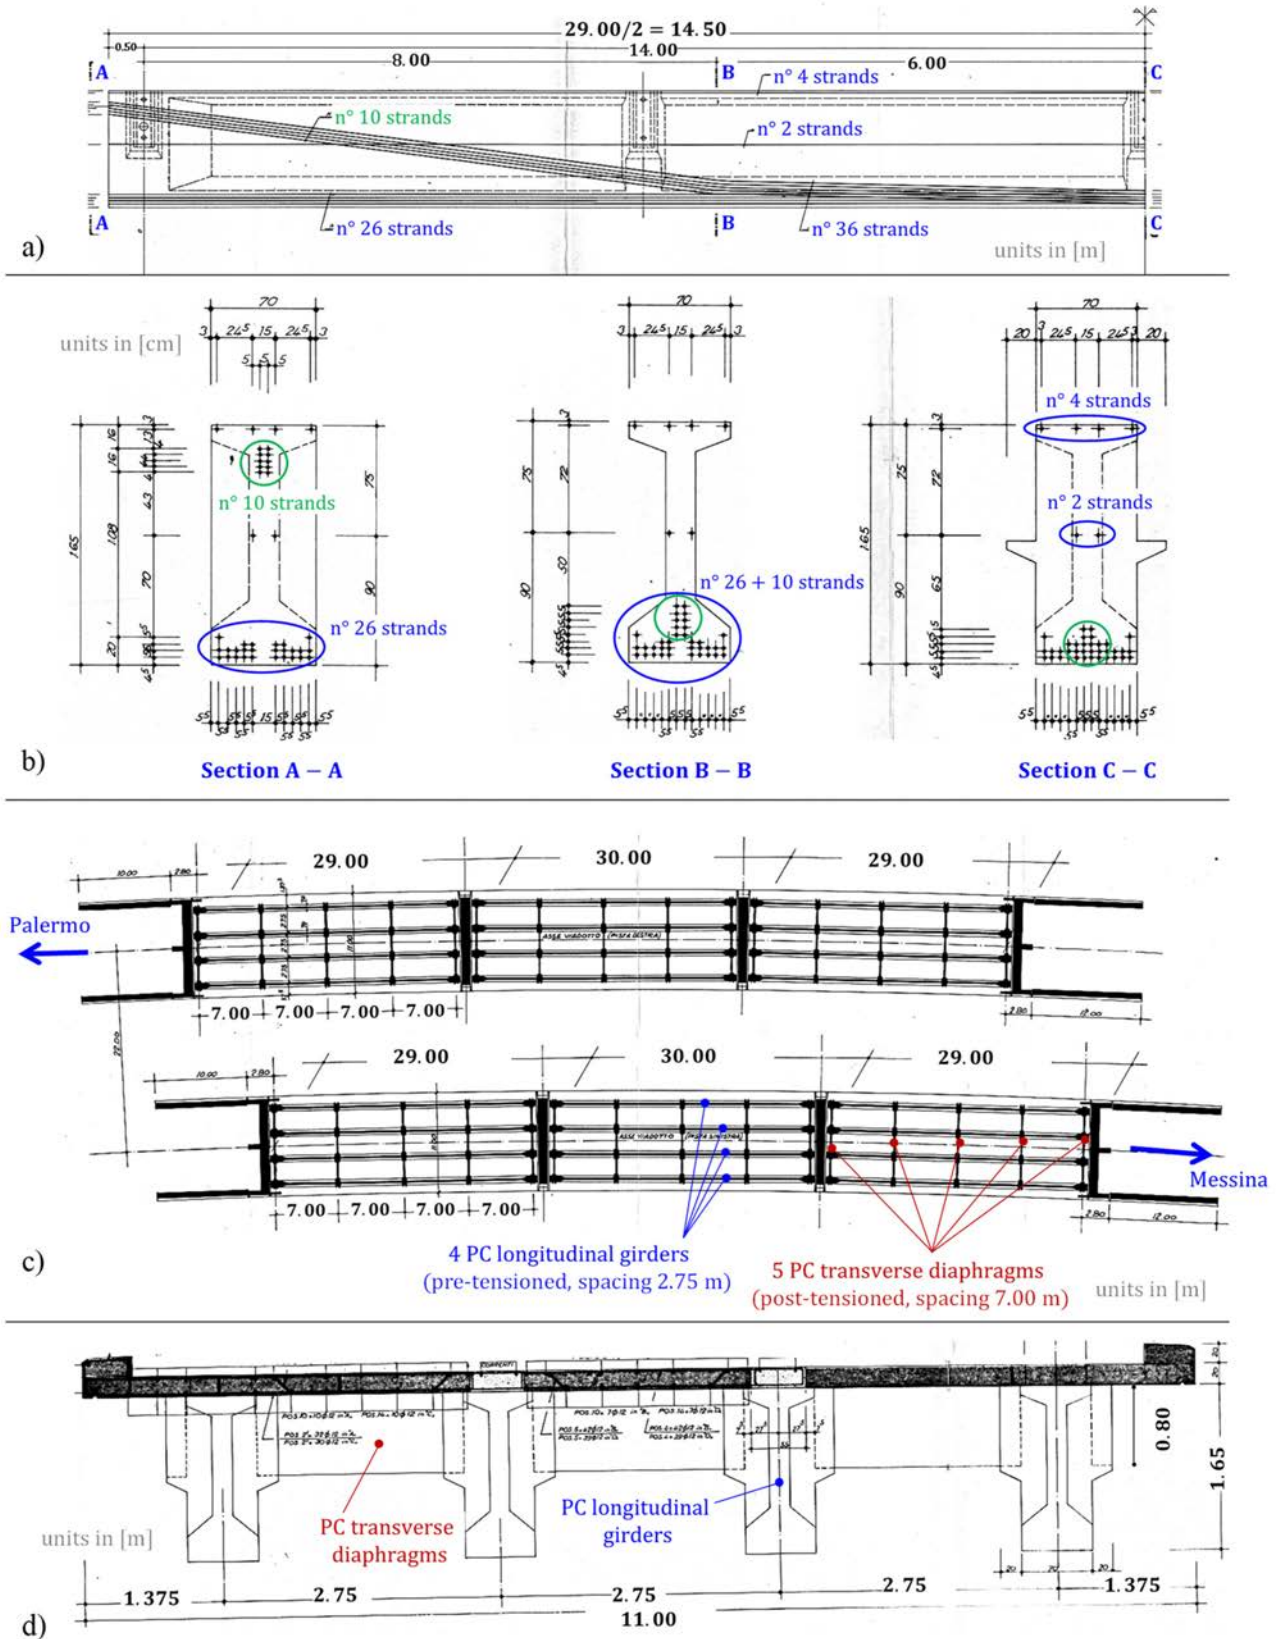
Figure 2. Original design drawings of the Longano viaduct: (a) configuration of the prestressing strands in longitudinal girders; (b) cross-sections of PC girders; (c) horizontal section of the bridge deck (two independent roadways); (d) transverse section of the bridge deck.

8 m from the supports (see Figure 2a,b) that show just one half of the girder reinforcement configuration up to midspan, the other half being perfectly symmetric). The longitudinal I-shaped PC girders, of height 1.65 m and width 0.70 m, are mutually connected through transverse PC (post-tensioned) diaphragms (5 per each span), having rectangular section (20 cm × 80 cm) and spaced 7.00 m (see Figure 2c,d) showing the horizontal and transverse sections of the bridge deck). The PC girders are simply supported on neoprene bearings having dimensions 0.60 m × 0.45 m × 0.064 m. In the transverse direction, the bridge deck has a couple of RC seismic restraints realized in the pier cap and in the abutments. As to the materials adopted, the original design drawings report concrete grade C35/45 (cylindrical characteristic strength ≥ 35 MPa), prestressing strands with ultimate tensile strength greater than 1667 MPa and reinforcement bars (of RC slab) with yielding stress greater than 430 MPa and ultimate strength greater than 540 MPa.

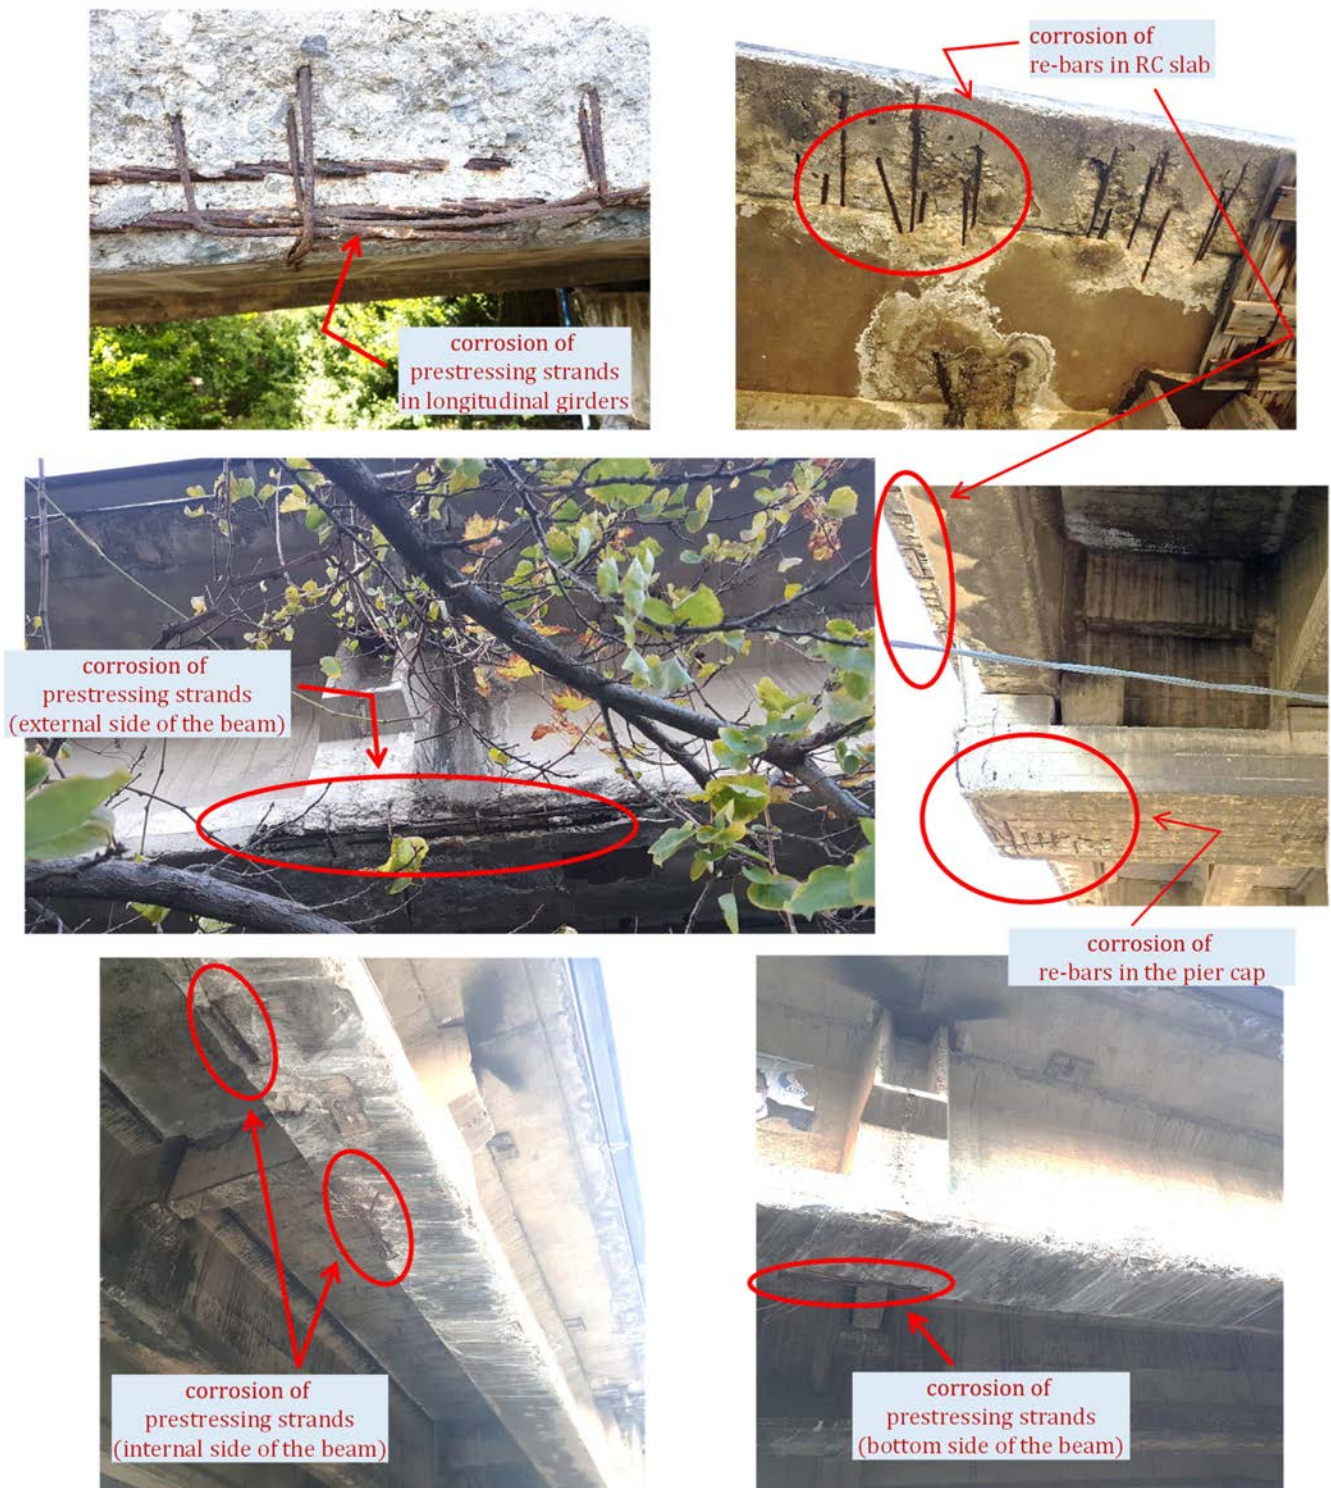
Figure 3. Widespread corrosion state of the Longano viaduct detected from visual inspection.

According to the multi-level approach recommended by the Italian Guidelines for bridges [9], after the level-0 process of data collection of the bridge, including location, design drawings to identify structural system, check for past reports of retrofit interventions, etc. [27], the next level 1 concerns a visual inspection on the bridge with the aim to detect existing damage signs, including (among others) cracking spots, spalling of concrete cover and, most importantly, steel corrosion. A set of photographs taken on different parts of the Longano viaduct is reported in Figure 3. It is clearly noticed that there is a widespread deterioration state along the bridge deck with concrete cover completely removed in extensive portions of the girder soffit and marked corrosion phenomena in prestressing strands (more pronounced in the strands located in the bottom part of the I-shaped section) as well as in the mild steel bars of the RC slab. On the contrary, the inspection does not reveal any damage state in the transverse diaphragms (neither cracking, nor concrete spalling, nor corrosion of steel tendons).

Based on the preliminary data acquired during the visual inspection, it is reasonable to think that the observed corrosion phenomena of prestressing strands might have reduced the sectional capacity of the PC longitudinal girders. Depending on the initial prestressing force considered in the design stage and the extensiveness of the corrosion process (which are two unknown parameters), theoretically speaking, the reduced steel area of the strands may either affect the ultimate limit states only, or also influence the sectional capacity under serviceability loads. Indeed, it is not easy to foresee whether the corrosion rate is such to produce the cracking state under service loading conditions. Should this critical scenario of cracking under service loads occur, the evolution of damage state detected from the visual inspection might evolve more and more rapidly under service traffic loads. It is, therefore, of extreme importance to check the structural behavior of the bridge under serviceability loads (up to the maximum loads allowed by the Italian regulations NTC2018 [10]). To this aim, static load tests on the bridge deck are planned to reproduce such extreme service loading conditions corresponding to the characteristic combination of loads reported in the Eurocode 0 [28] §6.5.3, with unitary combination coefficients for variable actions (normally used for irreversible limit states). However, before performing such static load tests, it is decided to preliminarily identify natural frequencies, mode shapes and damping ratios of the bridge through OMA (collecting free vibration data). These dynamic characteristics serve as useful indicators of the bridge structural health and are, therefore, checked and compared prior to and after the static load tests to assess whether some irreversible damage is caused by the applied loads. The description of the in situ experimental campaign is reported in the next section.

Based on the visual inspection, the bridge is subject to widespread corrosion phenomena concentrated only in the prestressing strands (cf. again Figure 3). Although it has been experimentally and numerically demonstrated that the corrosion does not affect the structural behavior of the bridge under service loads, it is reasonable to expect that the load-bearing capacity of the bridge deck at the ultimate limit states is seriously influenced by the corrosion-induced reduction of the cross-sectional area of the prestressing strands. Unfortunately, no experimental measurements of the actual corrosion rates are available so far, but they are planned for the near future. However, it is of utmost importance to gain insights, or at least to obtain preliminary estimates, on how the corrosion of steel strands affects the load-bearing capacity of the bridge. To this aim, this section is devoted to investigating, from a numerical point of view, the ultimate limit-state behavior of the bridge deck accounting for different (hypothetical) corrosion scenarios of prestressing strands. The results from this numerical investigation will be useful to quantify the risk level of the infrastructure associated with different extents of corrosion (whose actual values will be identified through subsequent experimental findings).

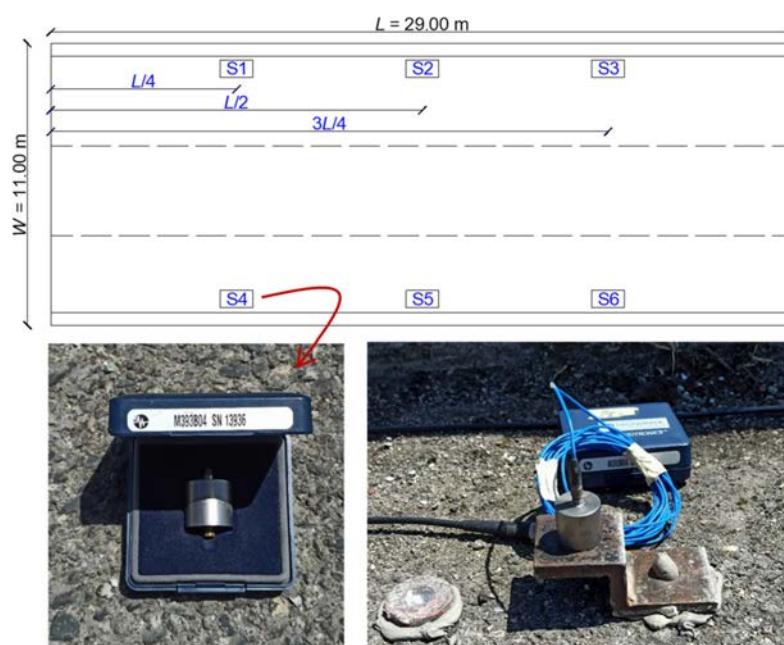
Figure 4. Position of the six accelerometers (S1–S6) on the bridge deck (**top**) and representative accelerometer photograph (**bottom**).

Six accelerometers with vertical axis are installed on the bridge deck (following an identical scheme in the two independent roadways). The accelerometers are placed symmetrically with respect to the roadway width and are rigidly anchored to the RC slab at $1/4$, $1/2$ and $3/4$ of the span, cf. Figure 4. The signal acquisition is performed with sampling rate $\Delta t = 0.001$ s (sampling frequency $f_s = 1$ kHz). The range of accelerometer sensitivity is (912–1006) mV/g for the six devices employed, with g being the acceleration of gravity.

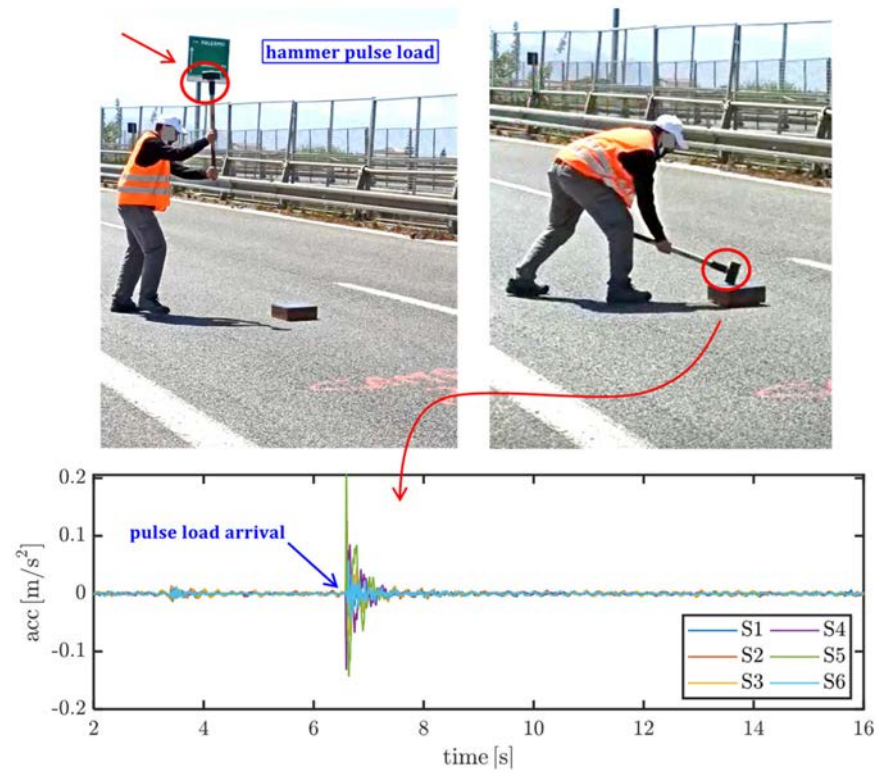
Figure 5. Dynamic excitation of the Longano viaduct with a pulse load produced by a 4 kg hammer blow and related filtered acceleration signals.

Two different excitations are considered to trigger free vibrations of the bridge deck and to identify the largest possible number of modal parameters: (1) pulse load exerted by a 4 kg hammer, as illustrated in Figure 5, which is applied to three different positions, namely at a quarter of the span (from either side) and at midspan; (2) step load exerted by the transit of a three-axle heavy truck (with gross weight of 347 kN) passing on a 12 cm step, as depicted in Figure 6, which is applied to three different positions, namely at a quarter of the span (from either side) and at midspan.

In the postprocessing phase of the recorded signals, the acceleration time histories are subjected to a Butterworth filter of order 6 to remove the frequencies falling outside the range of interest, here selected as (3–40) Hz. Subsequently, each recording signal is processed in the frequency domain through the fast Fourier transformation (FFT), a representative example of which is shown in Figure 7. It is worth noting that the two types of excitations (hammer pulse and truck transit) affect the modal response to a rather different extent: the hammer blow pulse generally amplifies a wider range of frequencies,

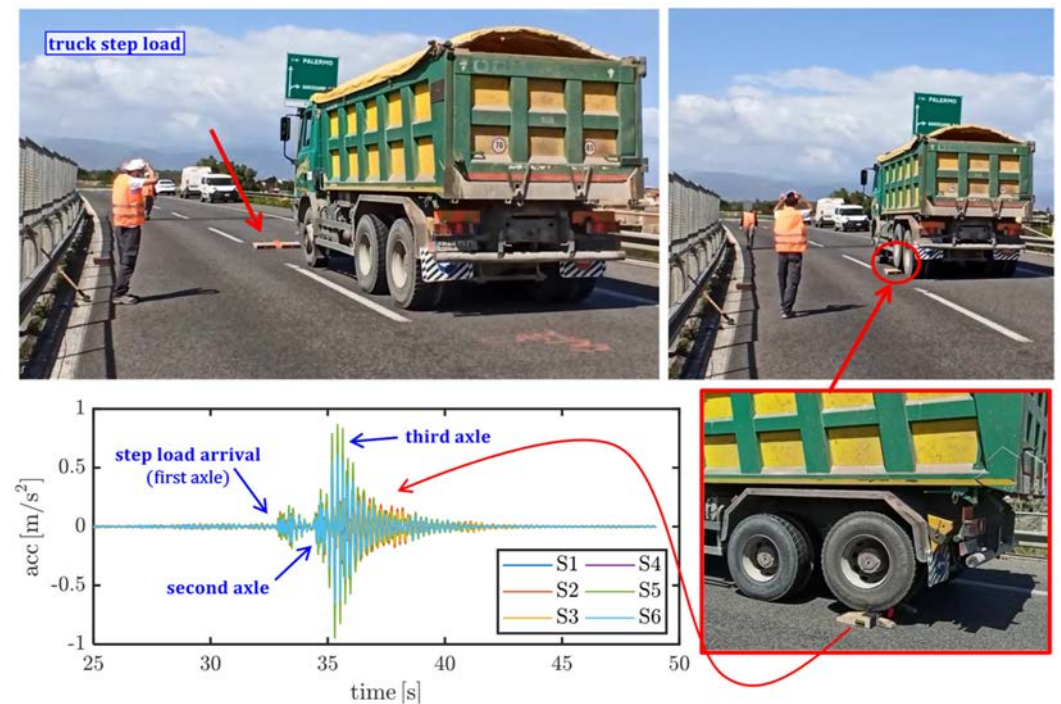
Figure 6. Dynamic excitation of the Longano viaduct realized with the transit of a three-axle 347 kN gross-weight truck on a 12 cm step and related filtered acceleration signals.

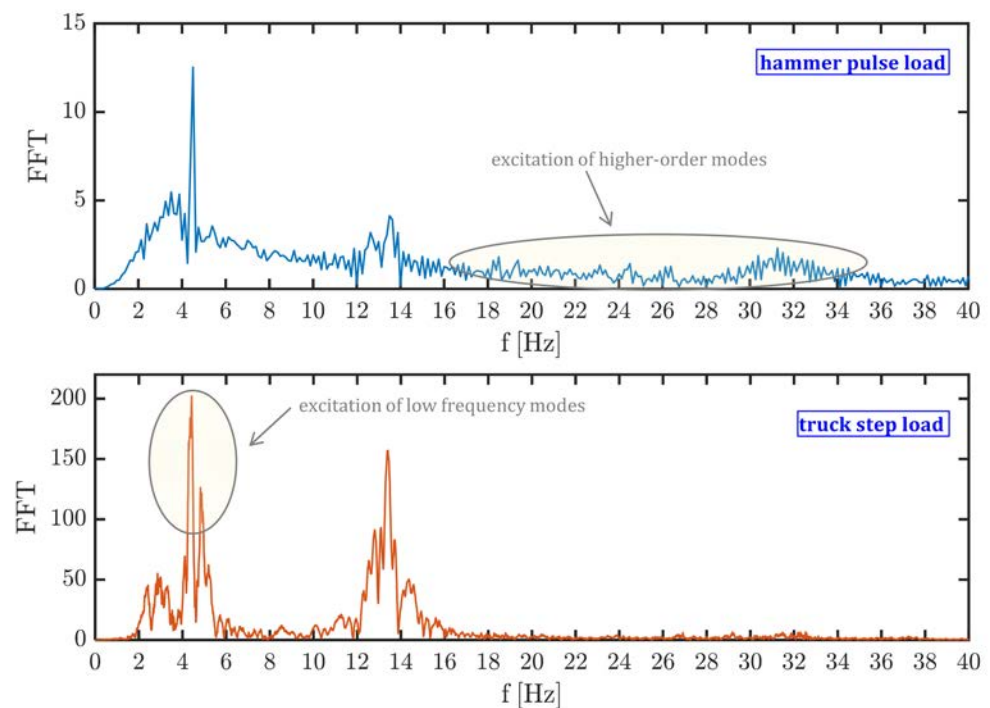
Figure 7. FFT of the S1 signal under hammer pulse load (**top**) and truck step load (**bottom**).

including higher order modes, whereas the transit of the heavy truck mainly excites the first (low frequency) modes of vibration, cf. again Figure 7.

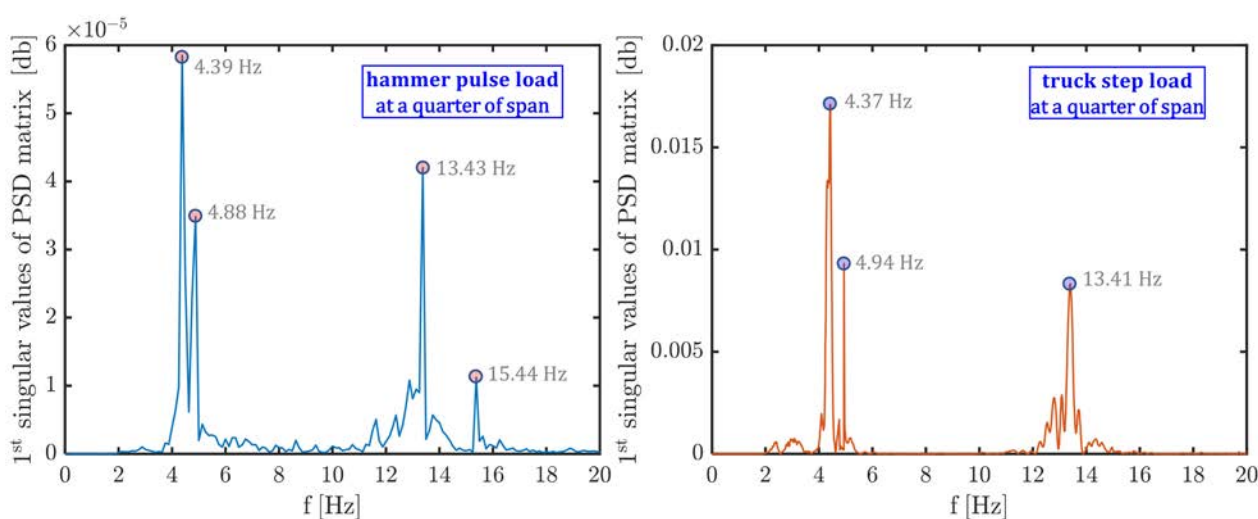
Figure 8. Identification of natural frequencies based on peak picking from the first singular values of the PSD matrix.

The determination of natural frequencies and mode shapes from the PSD matrix assumes that near the resonant frequency of the structure (where there is only one dominant mode) the singular vectors represent estimates of the mode shapes, and the corresponding singular values represent estimates of corresponding natural frequencies. Some representative examples of singular values of the PSD matrix and the resulting identification of the natural frequencies by peak picking technique is illustrated in Figure 8.

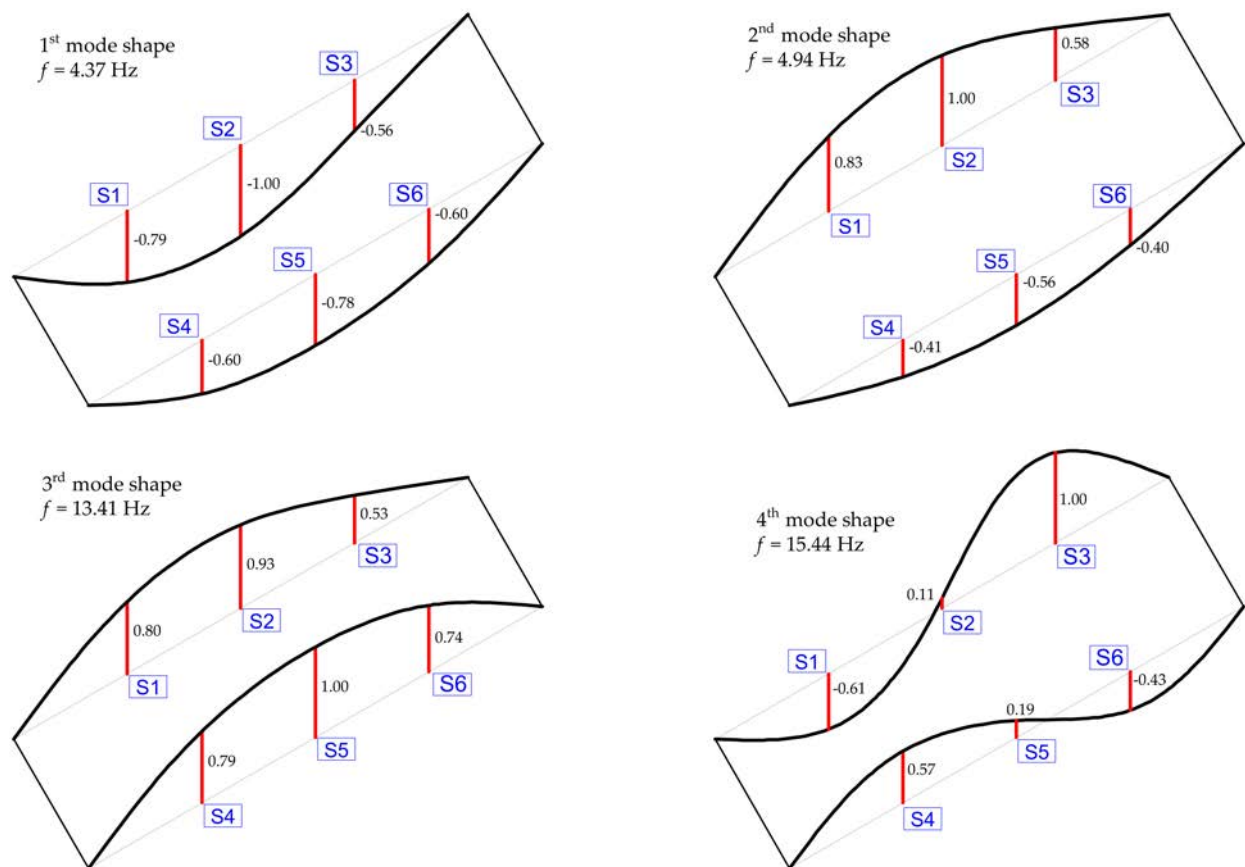
Figure 9. First four mode shapes identified from OMA before static load tests.

The list of natural frequencies identified from OMA is reported in Table 1 for each excitation configuration considered in the experimental campaign, while the first four mode shapes are illustrated in Figure 9. These results are relevant to the dynamic tests performed in the roadway from Palermo to Messina; however, similar results (not shown here for brevity) are obtained in the twin roadway from Messina to Palermo. It is worth noting that the mode shapes are identified by the modal coordinate corresponding to each of the six accelerometers. Since these six accelerometers are placed on the two sides of the bridge deck, it is not easy to distinguish between longitudinal flexural modes (mainly involving longitudinal PC girders) and transversal flexural mode (mainly involving transverse diaphragms) of the bridge deck. To capture this detail, additional accelerometers along the width of the deck (e.g., at $W/4$, $W/2$ and $3/4 W$) should have been placed. Despite the relatively low number of signals, it is possible to foresee, based on the results in Figure 9, that the first and third vibration modes are of flexural type, while the second and fourth modes are of torsional type. These conclusions can be inferred by the critical analysis of the modal displacements: in the first and third modes the modal displacements related to the two sensor lines (i.e., S1-S2-S3 and S4-S5-S6) have the same sign, which indicates a flexural (longitudinal or transversal) deformation of the bridge deck, whereas in the second and fourth mode, they have opposite signs, which denotes a torsional deformation of the deck. The obtained results are useful for the development of the numerical FE model of the bridge deck, which is described in the following subsection.

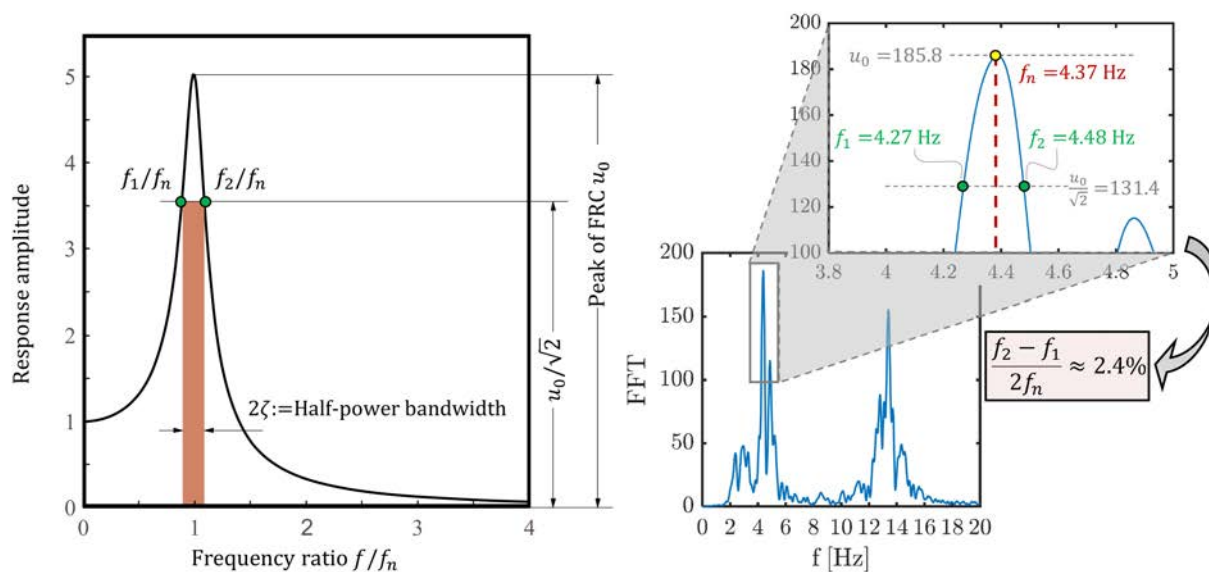
Figure 10. Identification of modal damping via half-power bandwidth: qualitative representation (left, adapted from Chopra [33]) and application to experimental frequency response curve for detecting the first mode damping ratio (right).

In addition to natural frequencies and mode shapes, dynamic tests are useful to identify the inherent damping ratio. Experimental measurements of damping ratios, typically achieved through the logarithmic decrement method or through the half-power bandwidth method [33], are useful to detect signs of damage of an existing structure. In this work, the second method is used to identify the damping ratio corresponding to the first and second modes of vibration. To this aim, the peak of the response amplitude (i.e., the resonant amplitude) u_0 is first identified from the frequency response curve (FRC), then the half-power bandwidth is computed from the frequency points at which the amplitude is $u_0/\sqrt{2}$ on either side of the resonant frequency f_n , namely f_1 and f_2 . These two frequencies define an interval of frequencies, called half-power bandwidth, that is twice the damping ratio ζ , see Figure 10. Thus, the damping ratio can be estimated as:

the S1 signal, which results in $\zeta_1 \approx 2.4\%$. Similar results are obtained for the other five signals. Experimental damping ratios (average values out of the six measures from the six accelerometers) of the first two modes identified for the two roadways separately are listed in Table 2. It is noted that average values of the first two damping ratios are approximately 2.5%, which are reasonable values for PC structural elements in elastic regime. These results suggest that there is no irreversible damage occurred or ongoing in the bridge deck, at least in the considered operating conditions.

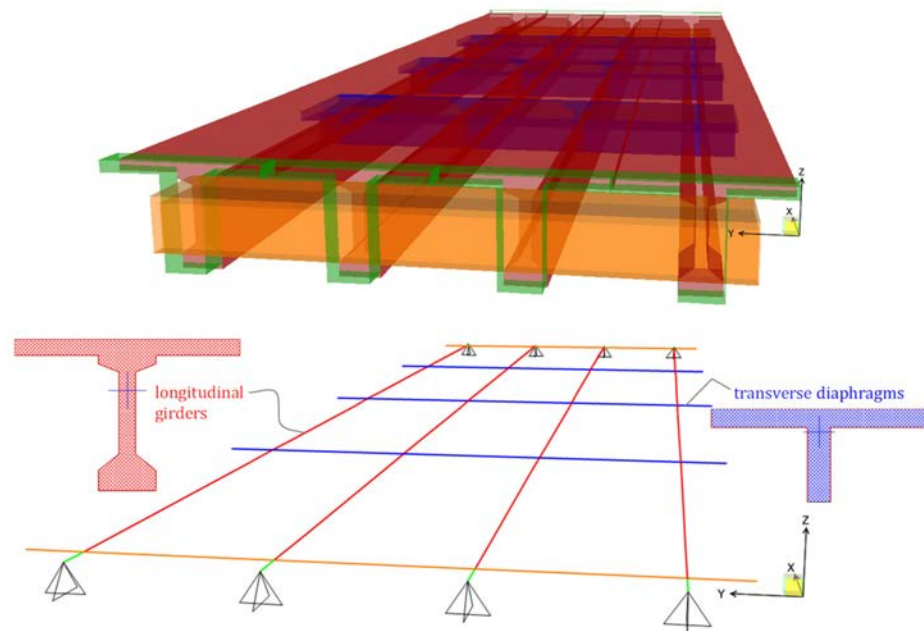
Figure 11. FE model of the bridge deck with 1D beam elements: extruded and standard view.

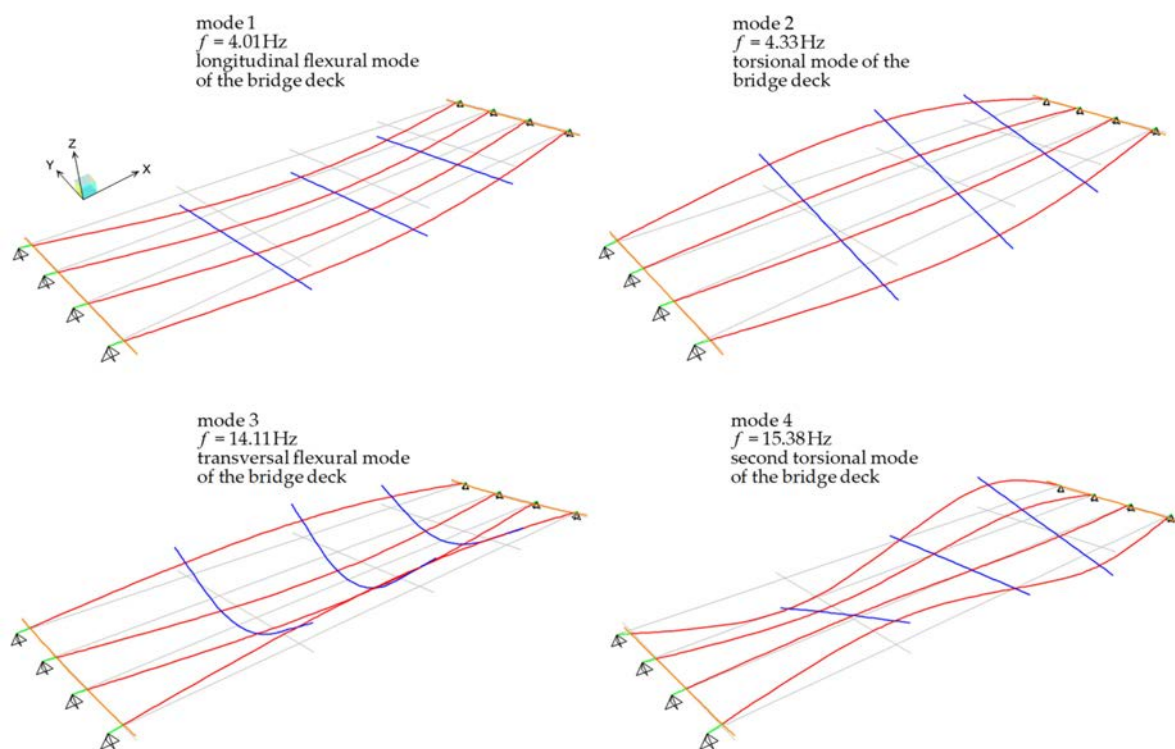
Figure 12. First four mode shapes obtained from FE model of the bridge deck.

Modal analysis (eigenvector analysis) is performed to determine the natural frequencies and mode shapes of the bridge deck. The first four modes of vibration along with corresponding frequencies are depicted in Figure 12. It is observed that the first (dominant) mode of vibration is, as reasonably expected, relevant to a longitudinal flexural mode of the bridge deck and has a frequency equal to 4.01 Hz. This frequency is only slightly different (8% lower) from the first natural frequency identified from OMA (4.37 Hz). The first natural frequency obtained by the FE model matches well with the theoretical first mode (flexural) frequency of a simply supported continuous beam with length $L = 29.00$ m and cross-sectional properties of the PC longitudinal girders (i.e., area $A = 1.13$ m² and moment of inertia $J = 0.4836$ m⁴). This first frequency can be analytically calculated as follows:

A stiffer behavior of the bridge deck is identified from OMA (first two frequencies equal to 4.37 Hz and 4.94 Hz) compared to that obtained from the numerical FE model (first two frequencies equal to 4.01 Hz and 4.33 Hz), which may be due to the stiffening effect of the RC slab in the actual configuration of the bridge that is only approximately included in the simplified FE model, or to slightly different support conditions related to possible wear in the neoprene bearings. Apart from these minor differences, the first four mode shapes from the FE model are qualitatively consistent with the experimental one, cf. Figure 12 with Figure 9, and the comparison between experimental and numerical natural frequencies is also reasonably acceptable (relative errors are listed in Table 3). It can be concluded that the simplified FE model developed is accurate enough to capture the dynamic characteristics of the bridge deck. Further validation of the model is performed in the next subsection to simulate static load tests.

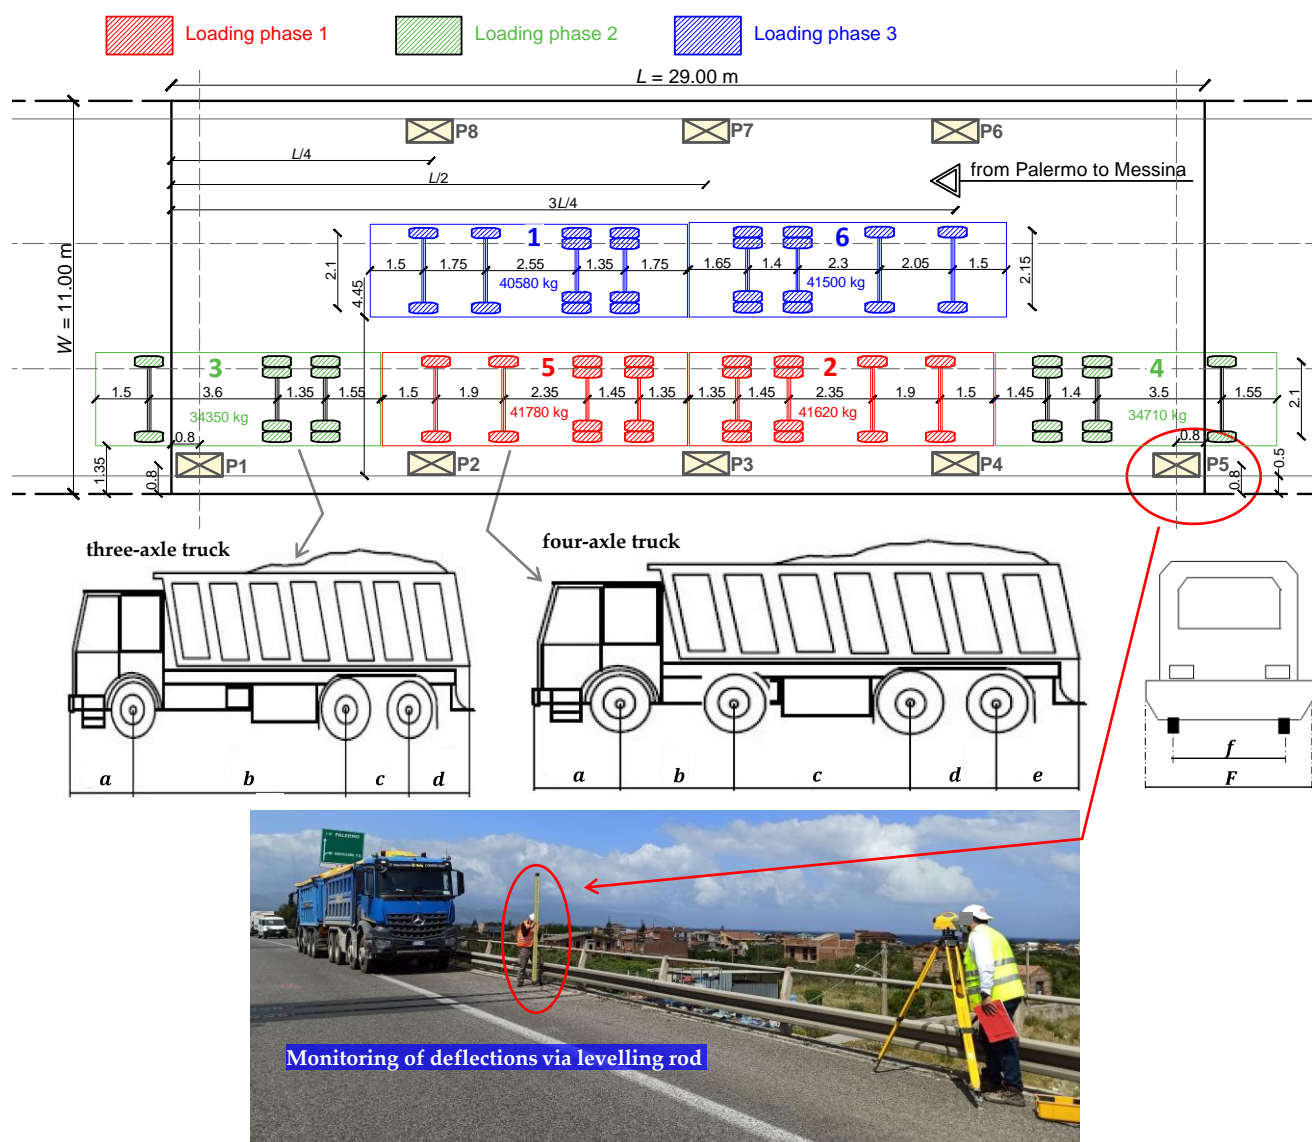
Figure 13. Plan of static load tests on the Longano viaduct deck with location of eight measurement points of displacement (P1–P8) and actual arrangement of three-axle and four-axle heavy trucks in three subsequent loading phases.

In the static tests, the loads are applied to the bridge deck by means of six heavy trucks identified by a unique ID (from 1 to 6), having either three or four axles. The truck loads are applied gradually in subsequent phases of increasing magnitude to check any possible sign of cracking or other damage-related phenomena. The layout of the actual truck loads relevant to the three phases is depicted in Figure 13 for the representative roadway from Palermo to Messina. However, a similar layout of truck loads is applied to the other roadway in the opposite direction (from Messina to Palermo).

Some measurement points of displacement are located on the two sides of the deck. More specifically, measurements of deflections are carried out via surveyor's levels located in eight measurement points of displacement P1-P8, namely near the two end supports (P1 and P5), at the midspan (P3, P7) and at the two quarters of the bridge span (P2, P4, P6, P8). The sensitivity of the considered instrumentation is of the order of two hundredths of mm, which represents a reasonable threshold considering the deflection values usually measured in bridges (including those reported in this experimental campaign).

Geometrical details of the trucks sketched in Figure 13 are listed in Table 4. Each truck is filled with coarse gravel such that the final gross mass reaches up to more than 34 t and 40 t for the three-axle and four-axle trucks, respectively. Some photographs taken during the various loading phases of the tests (pertinent to the roadway from Palermo to Messina) are reported in Figure 14. Between subsequent loading phases, a certain waiting time is expected to allow the stabilization of the deflection value. The time of loading phase 1 and 2 is of around 10 min, while that of phase 3 is of around 30 min to ensure stabilization of deflection. During the loading phases, the deck is monitored from below with a movable basket to control that all girders (including prestressing strands) do not exhibit any damage sign. After the three load steps, the unloading phase is performed by removing the truck loads following the opposite order of the loading phases.

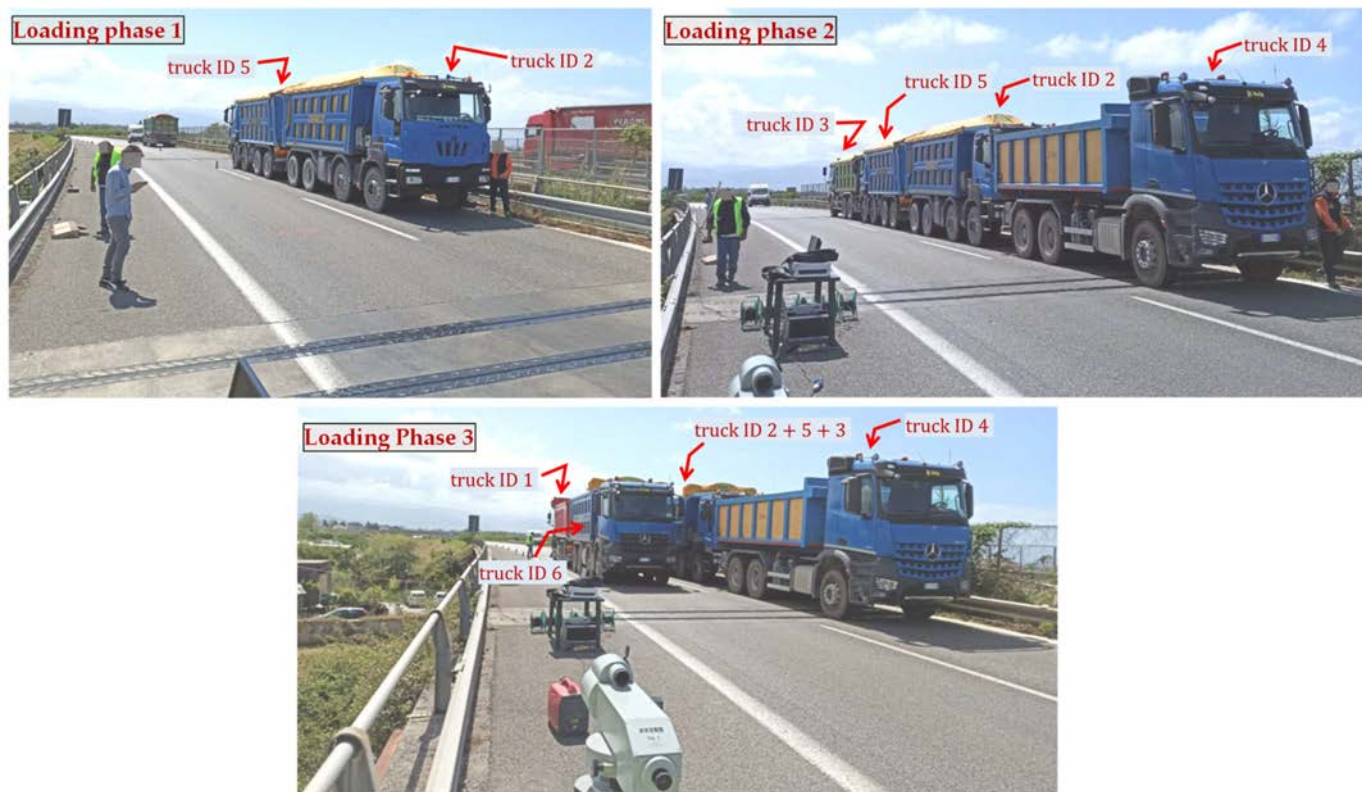
Figure 14. Photographs of static load tests in three subsequent phases for the roadway from Palermo to Messina.

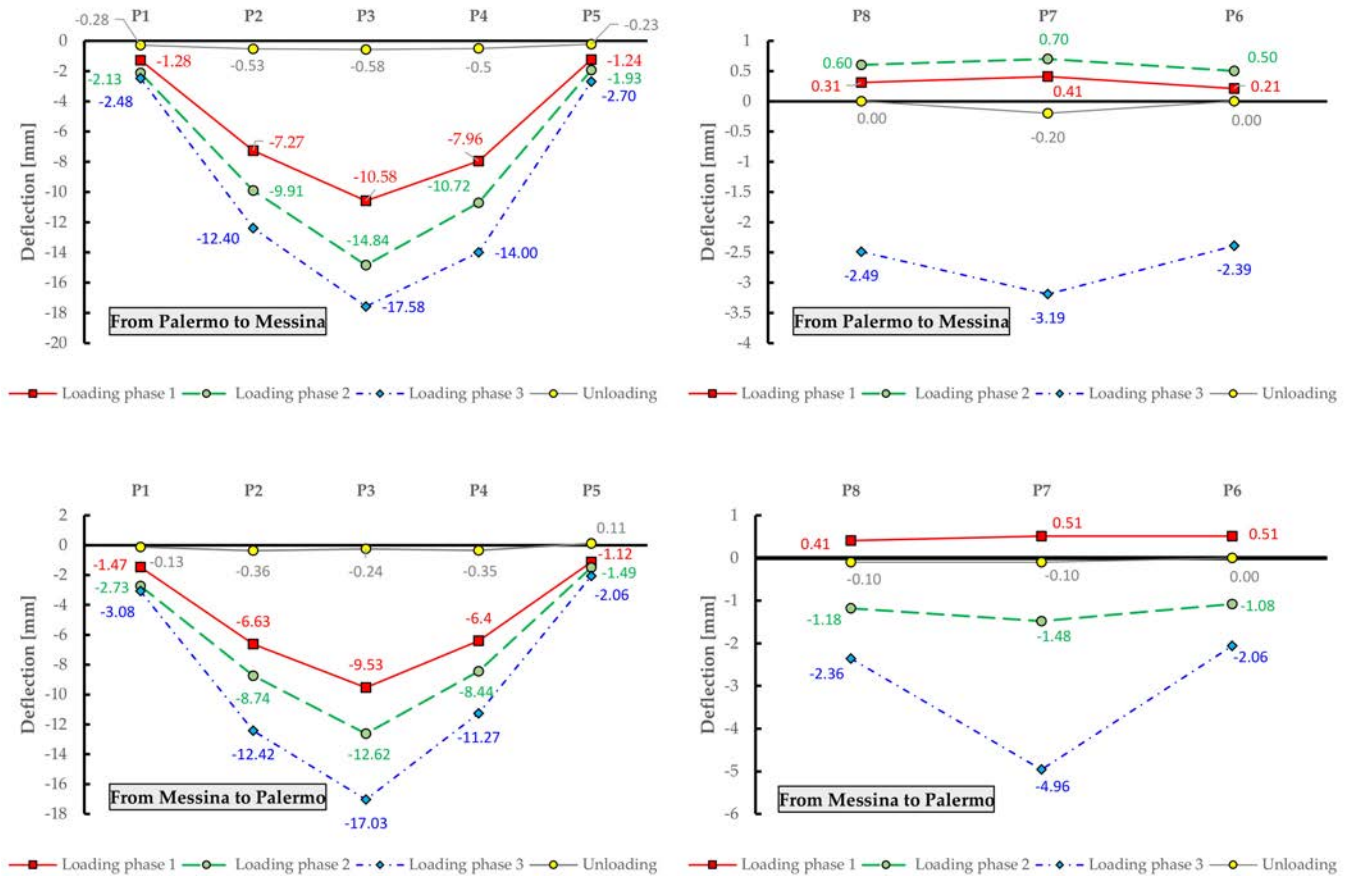
Figure 15. Experimental deflections for each measurement point obtained from static load tests on Longano bridge deck.

The measured deflections on the eight measurement points are reported in Figure 15, for each loading phase and for each traffic direction (roadway). It can be noted that the trend of the static deflections in the two roadways is substantially similar. Minor differences are observed when comparing the results from phase 2, which may be due to a slightly different arrangement of the trucks in the two roadways. The first loadings phases (especially phase 1) cause a positive displacement (i.e., raising of the deck) in the side

opposite to the loading area (see measured deflections for points P6–P8) as the eccentric truck loads induce a torsional response of the bridge deck. The maximum deflections measured in the midspan of the deck (P3) are approximately 17 mm for both the roadways. It can be observed that the residual deflection measured upon unloading are negligible and are largely below the 15% limit threshold prescribed by the NTC2018 [10]. These results lead to the conclusion that the corrosion of the prestressing strands (documented above in Figure 3) does not affect the structural behavior of the bridge under service loads, i.e., does not produce decompression phenomena under service loads. This seems to reasonably indicate that the level of initial prestressing force that was considered in the design stage is large enough to compensate the reduction of resistant area of the prestressing strands induced by corrosion.
