Article

A Combined Experimental-Numerical Framework for Assessing the Load-Bearing Capacity of Existing PC Bridge Decks Accounting for Corrosion of Prestressing Strands

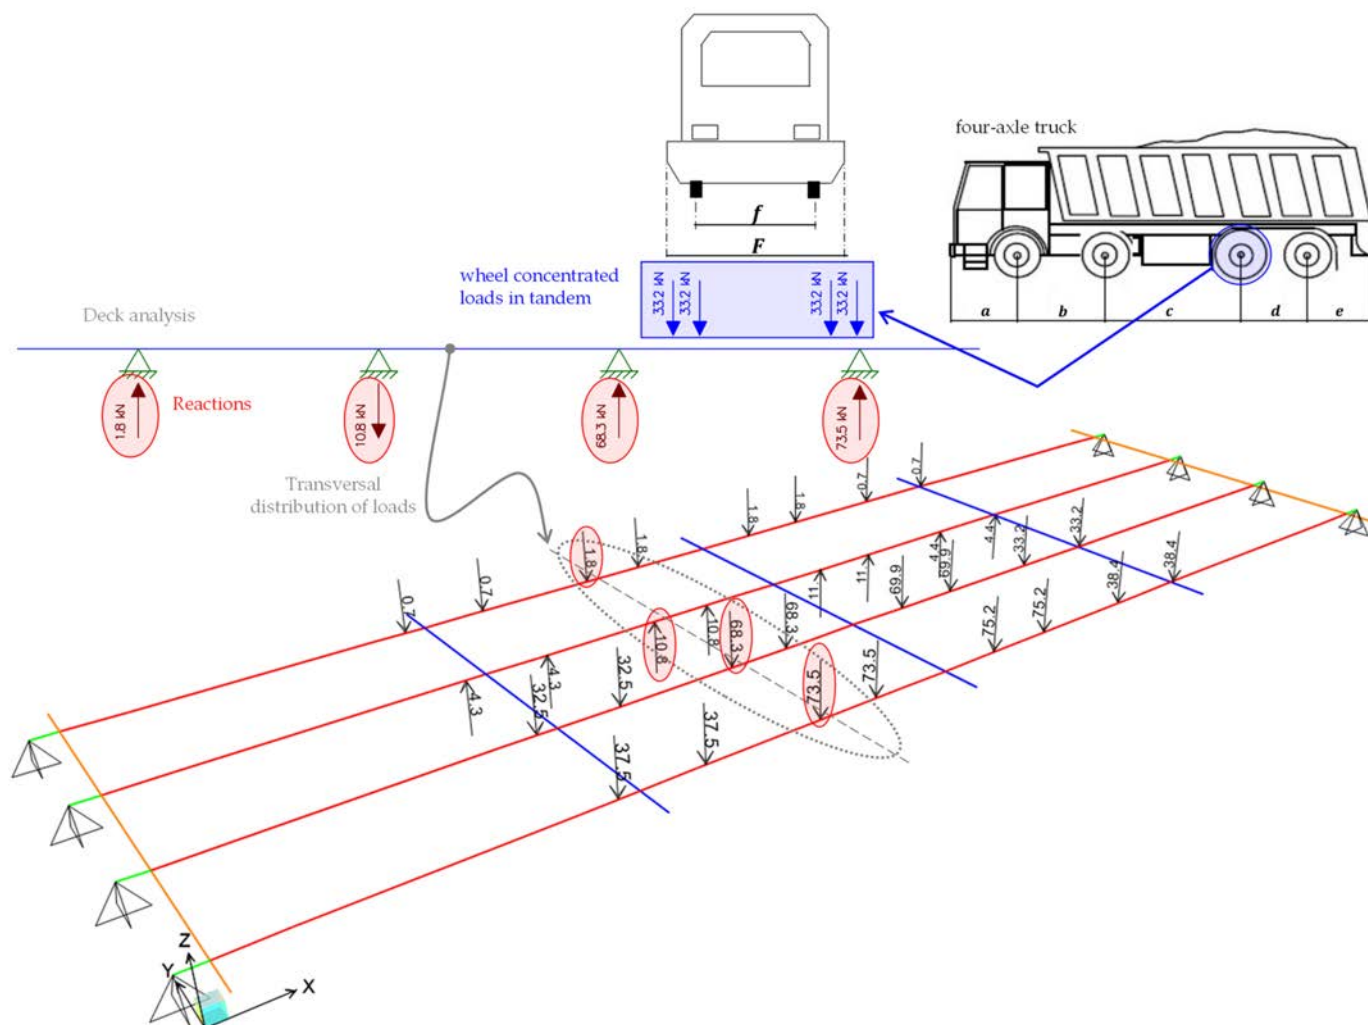
Figure 16. Simplified calculation of load distribution in FE model, representative example simulating loading phase 1.

Using 1D beams elements, loads can only be applied to the beam axis, whereas truck loads are transferred on the RC slab through wheel imprints that are generally not aligned with the beam axis. Consequently, to calculate equivalent loads on the longitudinal girders

generated by the trucks located on the bridge deck, a simplified scheme for a reasonable transversal distribution is adopted as shown in Figure 16. Here, the reactions of the supports in the deck analysis are applied as concentrated loads (in opposite direction) to the longitudinal girders of the FE model.

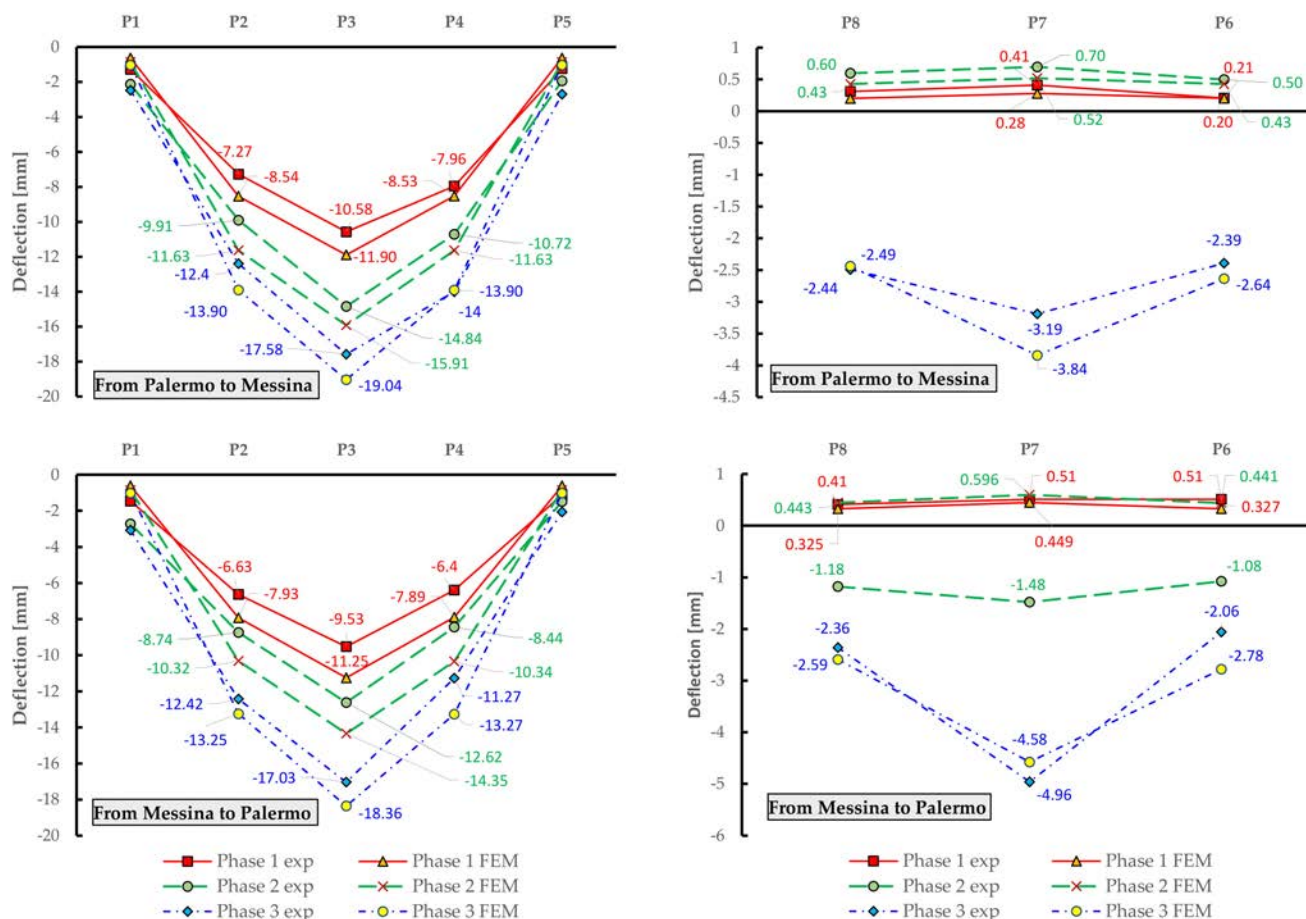
Figure 17. Comparison between experimental (exp) and numerical (FEM) displacements of the Longano bridge deck.

Once the truck loads are defined and implemented in the FE model, static linear analysis is performed to compute the deflections of the bridge deck. For comparative purposes, particular attention is paid to the deflections of those nodes closest to the eight locations of the measurement points considered in the experimental campaign. The comparison of the experimental (exp) and numerical (FEM) deflections is illustrated in Figure 17 for both the roadways (from Palermo to Messina and vice versa) and for the eight monitored points.

There is a reasonable agreement between the FE results and the experimental displacements, with average relative errors in the order of 10–15%. The highest discrepancies (30–40%) are observed in the measurement line P6-P7-P8, which is opposite to the loaded portion of the bridge deck. This may be ascribed to the simplified transversal load distribution adopted. It is also found that the FE model generally provides slightly larger deflections than the static load tests, which can be justified by the additional stiffening contribution of the RC slab that is only approximately incorporated in the resisting section of the longitudinal girders. Finally, some deviations between numerical and experimental results are noted (although not clearly shown in Figure 17) near the supports: it is expected that some minor displacements occur due to deformability of abutment and intermediate

pier in the experimental case that are not captured in the FE model using pinned restraints that prevent translations in the three directions. Apart from these critical considerations, it can be concluded the analysis results further validate the numerical FE model. In the next section, the validated FE model is used to investigate the ultimate limit state behavior of the bridge deck accounting for different corrosion scenarios.

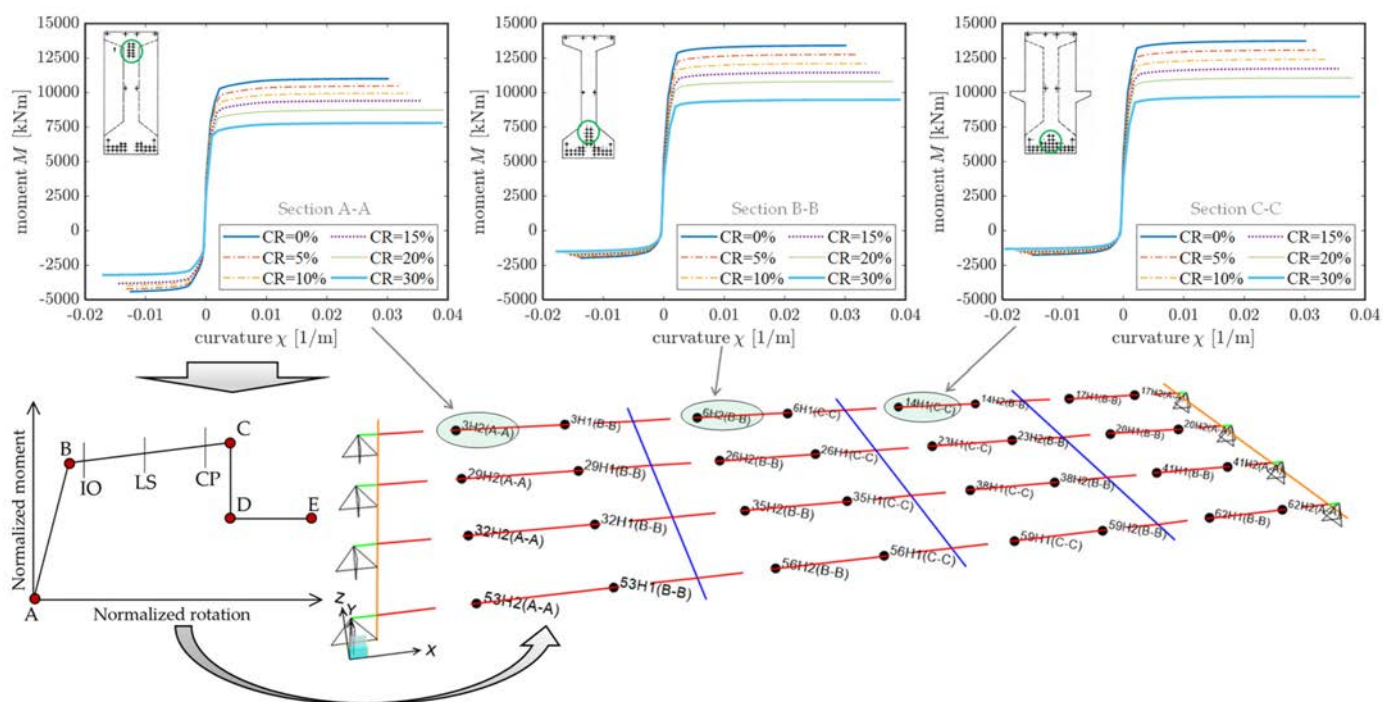
Figure 18. FE model of the corroded bridge deck with material nonlinearity simulated through a set of plastic hinges in longitudinal girders (concentrated plasticity approach) with properly calibrated moment-curvature relationships.

The nonlinear (concentrated-plasticity) FE model of the bridge deck is shown in Figure 18 along with the corresponding moment-curvature laws for the three representative sections A-A, B-B, and C-C, and for the six corrosion scenarios analyzed in this study. It can be observed that the ultimate moment decreases with increasing values of CR, while the ultimate curvature increases with CR because the failure tends to be more ductile, as it is achieved with a higher strain level in the corroded prestressing strands (having reduced resistant sections due to corrosion) than the uncorroded case. From the $M - \chi$ relationships, normalized moment-rotation curves are constructed and implemented in SAP2000 [35] based on a plastic hinge length equal to the section height. In a separate model, plastic hinges are also calibrated and implemented for the transverse diaphragms, besides those in longitudinal PC girders; however, it has been found that the yielding moment of these transversal elements, even in the most extreme loading and corrosion scenarios, is never exceeded, which implies that transverse diaphragms can be assumed as linear elastic elements for computational simplicity.

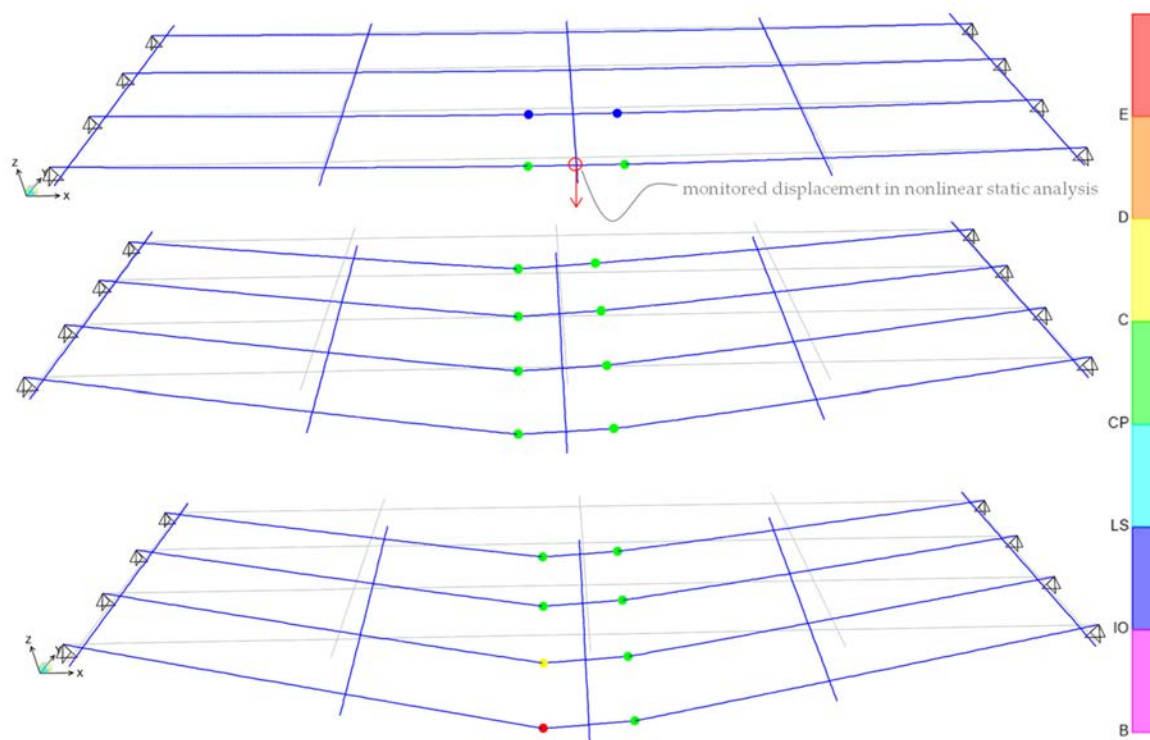
Figure 19. Deformed shape and plastic hinge development corresponding to three incremental loading steps (of increasing magnitude) during the nonlinear static analysis.

Displacement-controlled nonlinear static analysis is carried out in SAP2000 [35], by monitoring the displacement of the midspan node (on the roadway side that is mostly loaded) under loads of increasing amplitudes, as sketched in Figure 19. As reasonably expected, the development of the plastic hinges under monotonically increasing loads indicates that the most critical sections are those located near the mid span.

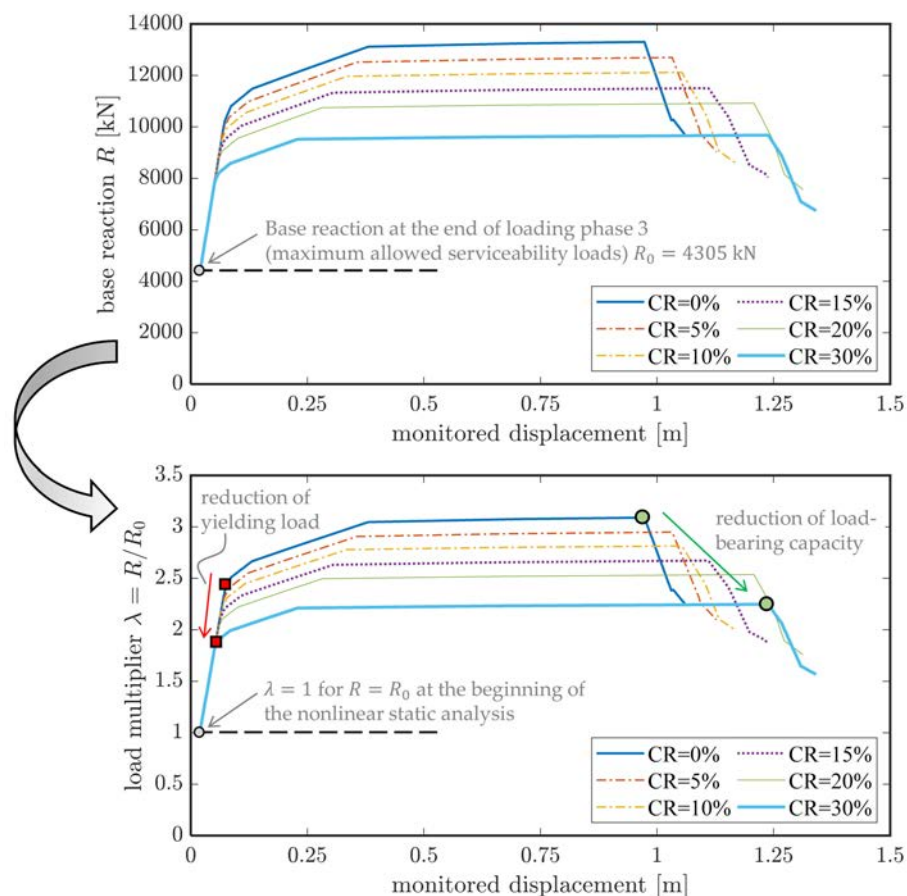
Figure 20. Results from nonlinear static analysis of the bridge deck: pushover curve (**top**) and corresponding load multiplier λ computed by normalizing the base reaction with respect to the value obtained at the end of loading phase 3 (**bottom**).

The pushover curves in terms of base reactions (sum of reactions of abutment supports and intermediate pier supports) versus monitored displacement are shown in Figure 20. It can be observed that the pushover curve starts from a base reaction $R_0 = 4305$ kN for all the corrosion scenarios, which corresponds to the end of loading phase 3, i.e., the reaction

computed under the maximum allowed serviceability loads. Further load increase (up to yielding load 8000–10,000 kN, depending on CR) is allowed by the bridge deck while remaining in elastic regime, after which the behavior becomes nonlinear. The corrosion evidently affects (reduces) the load-bearing capacity of the bridge deck.

For the generic step s of the nonlinear static analysis, the base reaction can be expressed as $R(s) = \lambda(s) \cdot R_0$, where $\lambda(s)$ represents a dimensionless load multiplier at the considered step s that quantifies the increase of the load beyond the elastic threshold at the end of loading phase 3. In addition to the pushover curve in dimensional form, the bottom part of Figure 20 reports the trend of such load multiplier λ versus the monitored displacement for the six considered corrosion scenarios. It can be easily observed that both the yielding load (i.e., the base reaction corresponding to the formation of the first plastic hinge) and the load-bearing capacity of the bridge deck (peak of the pushover curve) decrease with increasing CR values.

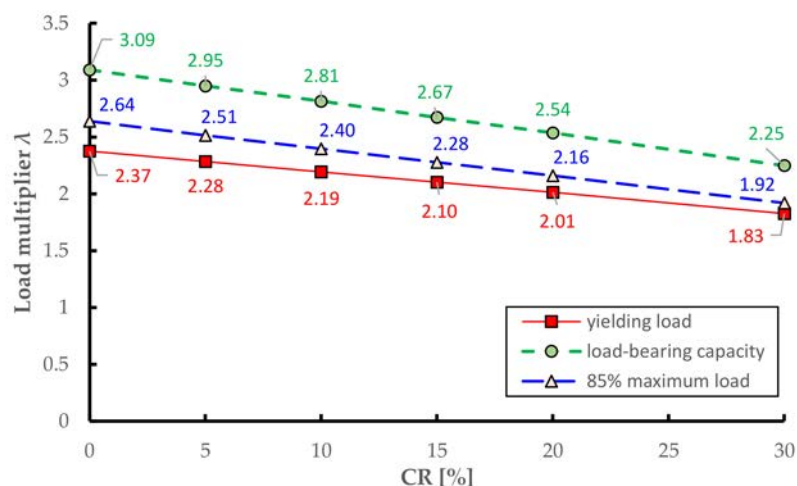
Figure 21. Reduction of load multipliers obtained from nonlinear static analysis of the bridge deck for increasing corrosion scenarios.

To summarize the main results, Figure 21 illustrates the trend of three characteristic load multipliers versus the CR value, namely the yielding load, the load-bearing capacity (maximum load) and the ultimate load calculated as the 85% of the maximum load. These diagrams are useful to preliminarily estimate the reduction of the load-bearing capacity of the bridge deck depending on the corrosion rate. The yielding load multiplier in the uncorroded case is 2.37, which means that the first plastic hinge formation occurs at a load level approximately two times and a half higher than that simulated in the loading phase 3 for the on-site static tests. This is a relatively high value considering the time of construction of the bridge, which confirms that the bridge is rather safe under the service

loads prescribed by the current regulations NTC2018 [10]. Moreover, the corrosion leads to a considerable drop of the three load multipliers, following a linear trend with almost comparable slope. In particular, the following linear regression formula well describes the decreasing trend of the load-bearing capacity of the bridge deck:

$$F_{\text{corroded}} = F_{\text{uncorroded}} - 0.028 \cdot \text{CR}[\%] \quad (4)$$
