Article

Geomorphological and Structural Assessment of the Coastal Area of Capo Faro Promontory, NE Salina (Aeolian Islands, Italy)

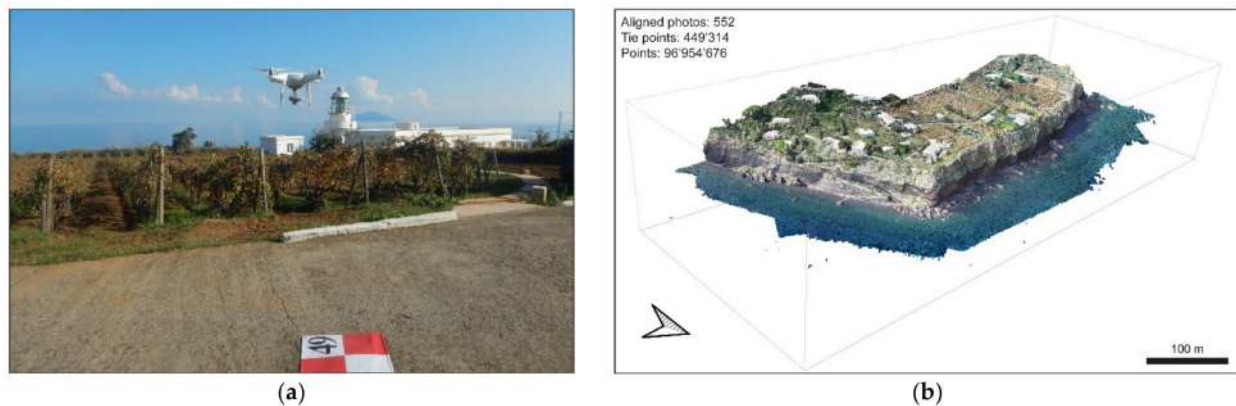
Figure 2. (a) The Phantom 4 Pro drone during its take-off in the flat courtyard of Capo Faro Estate; (b) Dense point cloud of the flight area in RGB colour, processed with the Agisoft Metashape software.

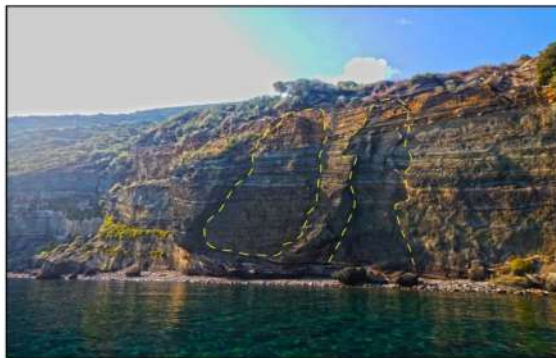
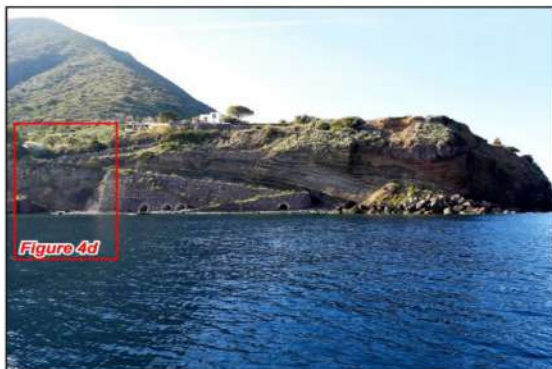
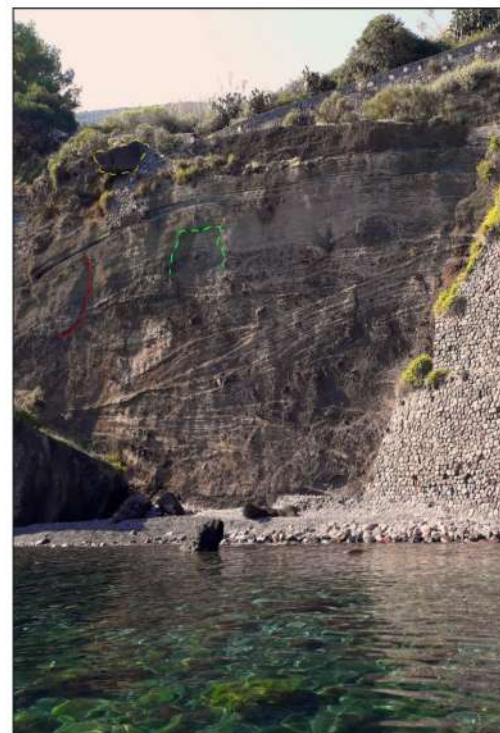
Figure 4. (a) The 3D model, generated after dense point cloud extraction by UAV photogrammetric flight through Agisoft Metashape, shows the flat area on which vineyards and buildings are located. It is bounded by an unstable coastal cliff with gravitational phenomena threatening the pocket beaches. (b,c) shooting areas are indicated by red squares; the yellow circle shows the zoomed 3D of Figure 6a; (b) Two large detachment surfaces and cavities of recent rockfalls characterising the cliff in question. The boulders in the foreground have an estimated size (through the dense point cloud) of about 1000 m³; (c) The eastern part of the sea cliff from the boat shows the impressive rock avalanche with the subsequent 30 m retreating at the tip of Capo Faro Promontory occurred in 2011. (d) shooting area is indicated by a red square; (d) A projecting big boulder (dashed yellow line) on the top of the scarp where a recent rockfall creates a detachment surface (dashed green line) parallel to the scarp. A red line indicates an open fracture in pyroclastic deposits.

The evolution of the coast in the study area represents a constant hazard factor for the buildings and the economy, linked to the high-quality vineyards upstream of the Capo Faro cliff. The retreating of the coastline, around 50–80 cm/y (PAI between 1992 and 2003), is directly caused by the succession of landslide events. It is still in progress nowadays, as testified by the relevant rock avalanche event in 2011 (Figure 4c).

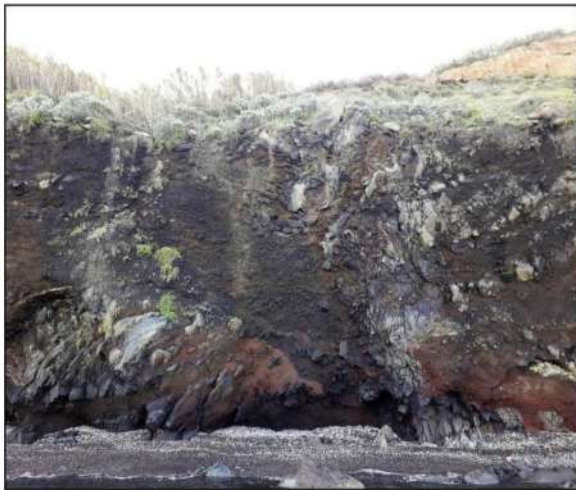
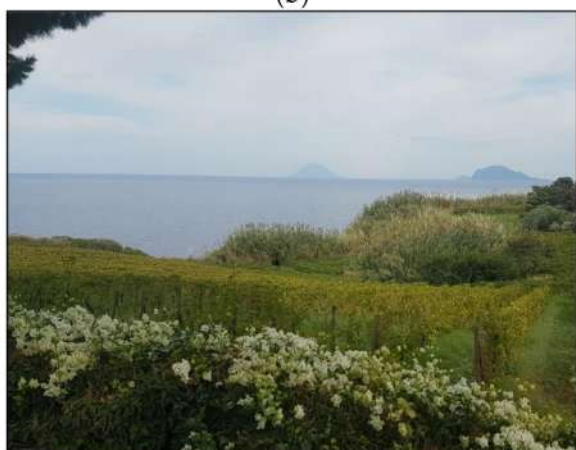
Figure 6. (a) 3D textured model focused on the intense gully erosion affecting the flat land right behind the edge of the coastal cliff. (b–d) shooting areas are indicated by red squares; (b) Hanging valley at the outlet of a wide channel. The erosive action of water caused the alteration of the pyroclastic deposits of the cliff; (c) The vineyard of Capo Faro Estate gently slopes into the hanging valley of (b); (d) The deep groove of a gully caused by runoff water.

The gravitational phenomena, dominant on slope acclivity $>35^\circ$, are: (i) rockfalls in the sub-vertical head of the narrow channels and along their sides; (ii) debris flows along the channels with the associated debris cones in sub-aerial environment, often truncated by the active coastal cliff; (iii) rockfalls, topplings (Figure 4b) and rock avalanches (Figure 4c) affecting the frontal portion of the cliff (Figure 4b). The presence of detachment surfaces and cavities on the cliff, in addition to the disseminated boulders of remarkable size standing on the beach (Figure 4d), suggests the system is in retreat. On the other hand, the coastal area of the Capo Faro Promontory is susceptible to storm surges from N–NW which generate a very etched swash line 4–5 m above the foot of the escarpments (Figure 5). The speed of the phenomenon of dismantling is evident in the rapid retreat of the drainage system (Figure 6a). In particular, the morphological jumps of the riverbeds (hanging valleys) near the cliff edge (Figure 6b,c) show how this process is sometimes faster than the incision of the ditches (Figure 6d). They thus remain suspended.

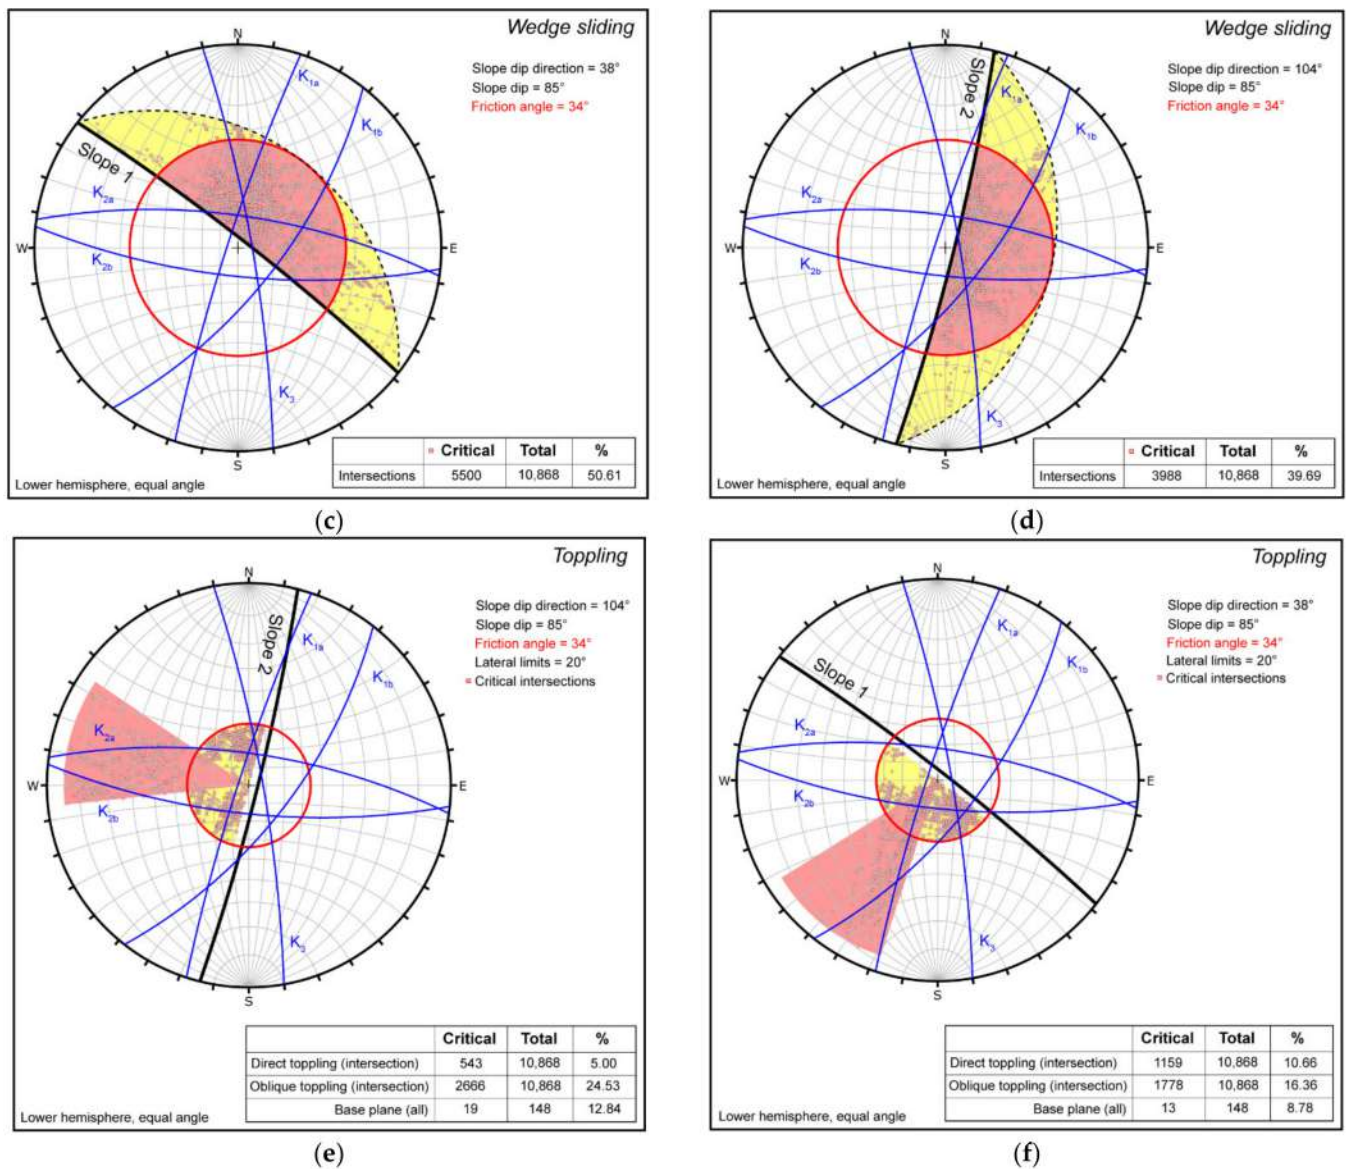
Figure 10. Stereographic equal angle plots (lower hemisphere) with the critical zones (red and yellow areas) for failure mode. (a) Planar sliding for Slope 1; (b) Planar sliding for Slope 2; (c) Wedge sliding for Slope 1; (d) Wedge sliding for Slope 2; (e) Direct and oblique toppling for Slope 1; (f) Direct and oblique toppling for Slope 2.

The slope stability assessment (i.e., Markland test) has been conducted near Capo Faro. The two main exposures (Slope 1 and Slope 2) of the coastal cliff with different orientations intersecting in correspondence with Capo Faro were analysed. Slope 1 orientation has been approximated to 38/85° (dip direction, dip) and Slope 2 is oriented 104/85°. The analysis has been made with the Dips[®]6 software for planar, wedge sliding and toppling (both direct and oblique). The thick black line is the slope orientation, and the red circle of 34° represents the friction angle (ϕ') (see Appendix A) measured for pyroclastic deposits and used as an input by the software for the test. The blue lines are the mean planes of the different systems. Planar sliding for both slopes, as provided by the software, gave thirteen critical poles (8.78% of the total) for Slope 1 and 19 (12.84% of the total) for Slope 2 (critical poles are in red in Figure 10a,b). For wedge sliding and toppling, Dips[®] projected all the intersections between the discontinuities (grey squares), marking with red and yellow areas those critical for triggering gravitational phenomena. Regarding wedge sliding, 5550 over 10,868 intersections (50.61%) have been evaluated as critical (Slope 1), thus falling in the reddish area, corresponding to the intersections between K1a and K3, K1b and K2a, K2a and K3, K1a and K2a systems (Figure 10c). In correspondence to Slope 2, 3988 intersections over 10,868 (36.69%) are critical for wedge sliding and correspond to K1b and K2a, K2b and K3, K1b and K2b, K1b and K3 (Figure 10d). Concerning the toppling mechanism, a number of 1159 intersections in Slope 1 (10.66% of the total) could be responsible for direct toppling (20° of lateral limits with respect to the slope dip direction; red area in Figure 10e), and 1778 (16.36%) for oblique toppling (yellow area; Figure 10e). The intersections critical for toppling in Slope 1 are between K1a and K2b, K1b and K2b, K3 and K1b, K3 and K2b. In Slope 2, 543 intersections (5.00%) are critical for direct toppling (red area with 20° of lateral limits; Figure 10f) and 2666 (24.53%) for oblique toppling (yellow area; Figure 10e). They correspond to the intersection between K1a and K2a, K1a and K2b, K1a and K3, K2a and K3.

The series of discontinuities characterising the cliff, besides being a preferential path for run-off water, could trigger planar and wedge slides and topple events. In particular, the K3 system, as already observed in Slope 2 (and in minor amounts in Slope 1; Figure 9b,e) and resulting from the Markland Test (Figure 10) is almost parallel to the analysed slopes and therefore could potentially trigger planar slidings. The test highlighted that some discontinuities of K2a and K2b systems in Slope 1 and K1a, K2b and K3 in Slope 2 could trigger these types of gravitational events (Figure 9a,b and *vc* Formation block in Figure 11d). Discontinuities in pyroclastic deposits of the *po* Formation both in slopes 1 and 2 intersect each other (K1a with K1b and K2a with K2b), making wedges of different dimensions (from metric- to decametric-scale). The Markland test (Figure 10c,d) confirms that these intersections among discontinuities previously observed on the field (Figure 9b–d) may trigger wedge sliding. Subvertical and horizontal discontinuities with a strike parallel to the cliff intersect originating several plurimetric parallelepipedal blocks which could topple (Figure 11d). This, again, has been confirmed by the Markland test for direct and oblique toppling (K2a and K2b for Slope 1 and K1a, K1b and K3 for Slope 2; Figure 10e,f).

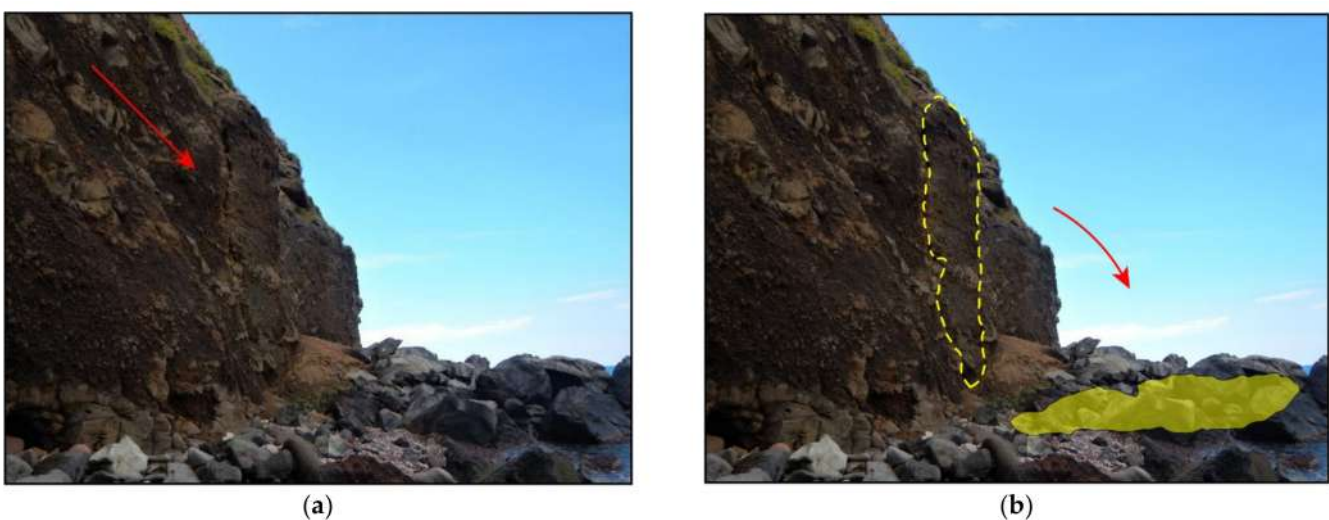
Figure 11. (a) The red arrow indicates the detachment cavity on the vertical cliff; (b) The deposits of the rockfalls and topplings coming from the cliff feed the pocket beach in front; (c) The lava flow referable to Vallone del Castagno Formation (*vc*) overlying the pyroclastic deposits of the Portella Formation (*po*). The left red arrow indicates the detachment area of the rock avalanche, the right one points to a fracture in the lava layer, warning of an incipient failure; (d) The cliff is retreating: the dashed green line indicates the crown of the rock avalanche in the vertical cliff; the yellow one the incipient detaching block, probably falling onto rock avalanche deposits. Detrital blocks maximum dimensions are about 70 m^3 , assessed with the dense point cloud.

from the dismantling of the pyroclastic rocks of the *po* Formation (Figure 11b). This lithotype constitutes about 60–70% of the sheer walls. This phenomenon could be limited by reinforcing structures such as wire meshes or anti-erosion blankets, whose adhesion to the walls is kept by soil nailing and steel rods. Furthermore, coastal works (e.g., brushes, artificial reefs) must be positioned aiming at the dissipation of the energy of the waves.
